**NOTE ON POST-DISASTER PRELIMINARY GEOLOGICAL STUDIES OF THE  
KOTLEN LANDSLIDE ALONG NH-37 (IMPHAL-JIRIBAM ROAD), 5 Km SSW OF  
KOTLEN, NONEY DISTRICT, MANIPUR**

**Visahono Zaphu, Sr. Geologist**

Project Landslide, GSI-NER, Dimapur

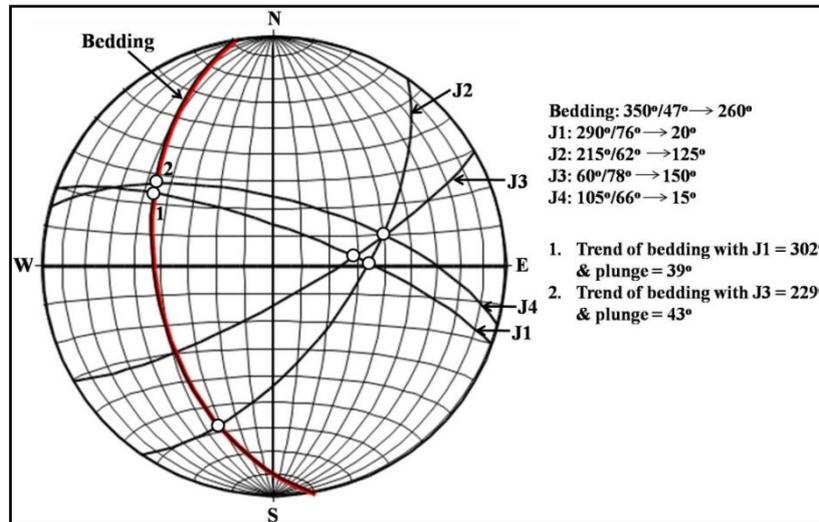
The trend of the bed in the study area is NNW-SSE ( $350^{\circ}/47^{\circ} \rightarrow 260^{\circ}$ ). Joints have been recorded in all the rock types of Disang Group. Sandstone beds show four sets of joints. The predominant sets of joints recorded in the area are: i)  $J_1$ :  $290^{\circ}/76^{\circ} \rightarrow 20^{\circ}$ , ii)  $J_2$ :  $215^{\circ}/62^{\circ} \rightarrow 125^{\circ}$  iii)  $J_3$ :  $60^{\circ}/78^{\circ} \rightarrow 150^{\circ}$  and iv)  $J_4$ :  $105^{\circ}/66^{\circ} \rightarrow 15^{\circ}$  along which sliding of the unconsolidated weathered materials occurred (Fig:1)

Fig:1. Stereographic representation of the structural data.

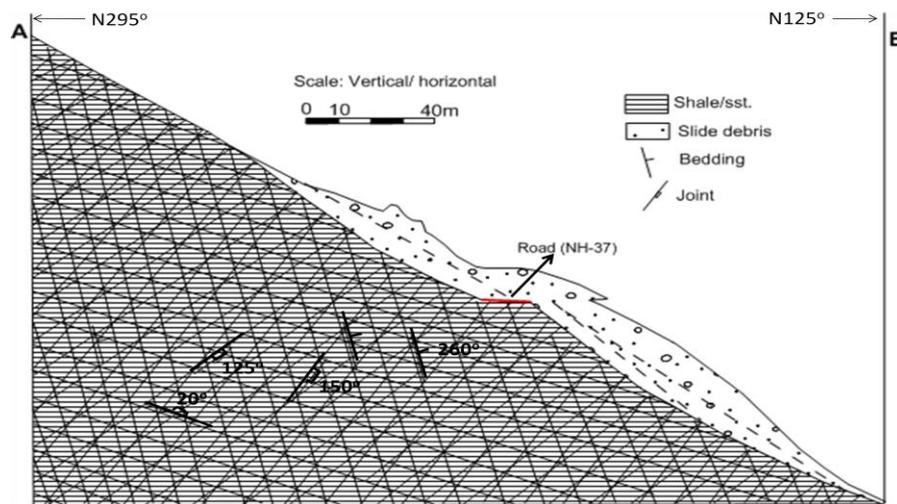
A section along AB line was prepared on 1:1000 scale (Fig. 2), to delineate shape of the slide and disposition of slided material along the length of the slide. Trend of AB line is 295°-125°.

Fig: 2. L-section along AB line.

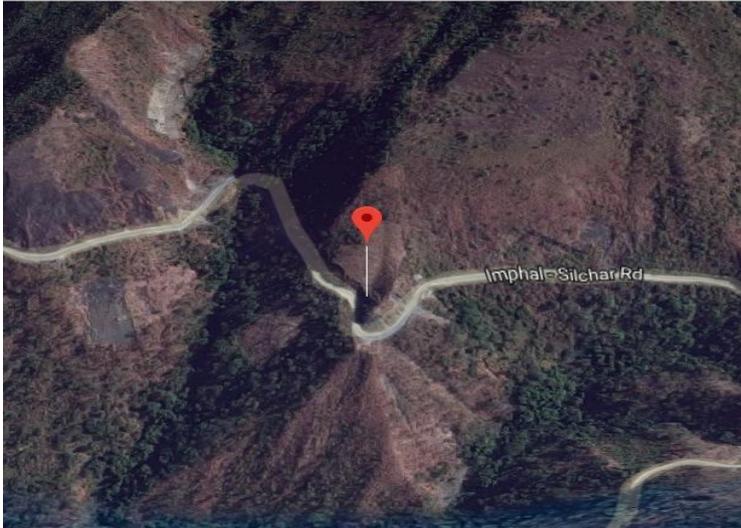
SSW of Kotlen, Noney district, Manipur (Photo 1). The affected area falls in SOI Toposheet no. 83 H/09 and the detail of the slide is provided in Annexure-I. At other places along the NH-37, 12 nos. of landslides of medium to small sizes has also been observed and respective latitudes and longitudes are mentioned Annexure-II.

**Photo 1:** Location of the slide from Google Earth imagery

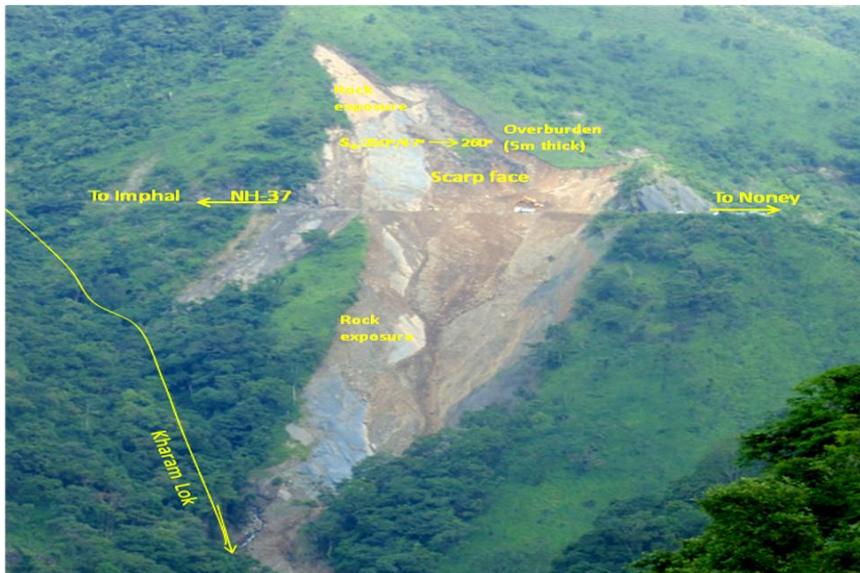
A second order perennial stream flows towards the right flank of the slide. Prior to the slide the area received heavy rainfall for many days. The slide was initiated on 12.06.2018 at around 18:00 hrs causing blockage to the highway. The authority maintaining the highway (HVS) cleared the debris to facilitate vehicular movement. Again the slide got reactivated in the early hours of 22.06.2018 and brought the vehicular movement to a halt on either side of the road. The highway authority (HVS) worked with heavy machinery to clear the debris off the road to ease the vehicular movement. There was no report of casualties except damage to the cable wires. The dimension of landslide is 95 meters in length and 130 meters in width with run out distance of about 200 metres (Photo 2).

**Photo 2:** Perspective view of slide Kotlen landslide.

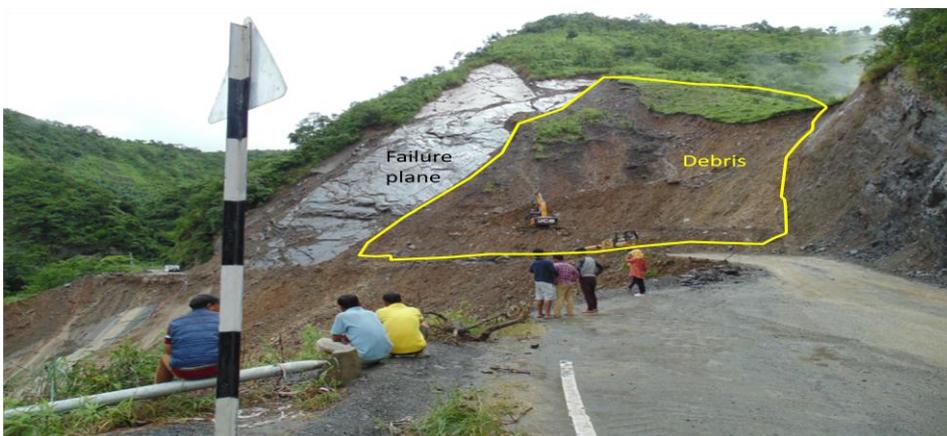
7. No cracks were observed in the proximity of the crown.
8. Debris were still sliding at the time of investigation and JCB excavators were employed by the authority (HVS) for clearing the debris to let vehicles ply from both sides (Photo 3).

**Photo 3:** Slide area showing debris on the failure plane. Heavy machinery engaged in clearing and removal of debris.

1. Removal of the loose overburden debris in the upslope portion (which is already been carried out by the road maintenance agency) Photo 3.
2. Channelling and diversion of rain water in the crown portion away from the slide area by constructing lined contour drains.
3. Lined contour and cross drainage to divert the surface runoff away from the road.
