FIELD DATA COLLECTION SHEET

No	Field	Description
1	Slide No (LS .No.)	<i>SKM/SOUTH/78A08/2017/001</i>
2	State	<i>Sikkim</i>
3	District	<i>South Sikkim</i>
4	Toposheet	<i>No. 78A/08</i>
5	Name of the slide	<i>Gumpa Monastery, Upper Gurpisey</i>
6	NH/SH/Locality	<i>State Highway (Namchi-Damthang Road, South Sikkim)</i>
7	Latitude	<i>27°10'20.02" N</i>
8	Longitude	<i>88°22'19.2" E</i>
9	Length	<i>20 m</i>
10	Width	<i>8 m</i>
11	Height	<i>10 m</i>
12	Area	<i>160 m²</i>
13	Depth	<i>2 m</i>
14	Volume	<i>320 m³</i>
15	Run out distance	<i>30m</i>
16	Type of Material	<i>Debris</i>
17	Type of movement	<i>Complex (Slide/ Flows)</i>
18	Rate of movement	<i>Very Rapid</i>
19	Activity	<i>Active</i>
20	Distribution	<i>Advancing</i>
21	Style	<i>Single</i>
22	Failure mechanism	<i>Shallow rotational failure</i>
23	History	<i>20. 09. 2017 at 02:00hrs</i>
24	Geomorphology	<i>Denudational hills (palaeoslide character, slope is 45°-50)</i>
25	Geology	<i>Bed rock- Phyllite covered with debris of fine matrix. Rangit pebble slate Formation of Gondwana Super Group</i>

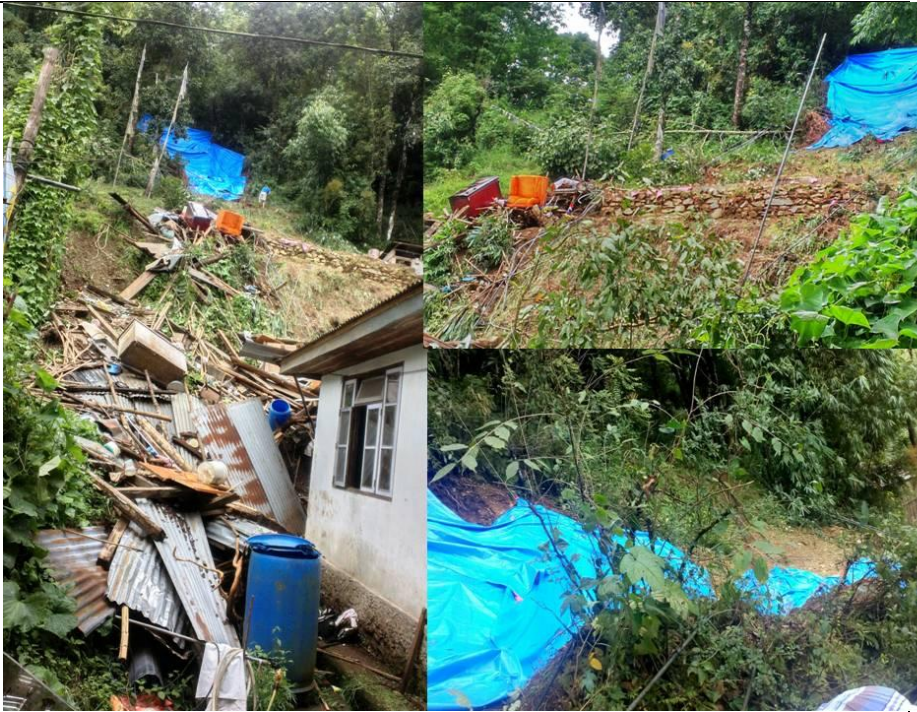
26	Structure	<i>NA (covered with thick soil cover) Failure plane: N50°E/40°SE</i>
27	Land use/ Land cover	<i>Moderately vegetated</i>
28	Hydrological condition	<i>Wet</i>
29	Triggering Factor	<i>Rainfall (heavy downpour)</i>
30	Death of persons	<i>3 Nos.</i>
31	People affected	<i>5 Nos.</i>
32	Live stock loss	
33	Communication	<i>Water supply line & electricity damaged</i>
34	Infrastructure	<i>2 houses damaged</i>
35	Agriculture/forest/Barren	<i>Forest</i>
36	Geo-scientific Causes	<i>Combination of factors like pore water pressure and reduction of strength on super- saturation, and unplanned cutting of slope</i>
37	Temporarily Remedial measures	<i>Initially the failure plane was covered with plastic sheet by the local people to avoid further penetration of water. However, proper drainage and retaining wall are suggested</i>
38	Remarks, if any	<i>The slide is of small magnitude as compare to other slides of the area. But due to sudden and rapid movement of earth material in the night time, casualty of three children of a family took place.</i>

<p data-bbox="539 757 1465 840">Fig. 1: Damage caused due to the Gurpisey Landslide, Namchi, South District, Sikkim.</p>
40	Summary/Abstract	<p data-bbox="539 840 1465 1249"><i>The failure was initiated early in the morning at around 02.00 hrs. Tragedy struck due to torrential rainfall over the past 24 hours. This caused loss of 03 human lives, injuries to 02 people and damages of property (Fig.1). A field visit was made to the affected area on 21.09.2017 for preliminary assessment of the landslide. Preliminary field observation confirmed that the Gurpisey landslide was characterised by a very rapid sliding movement along with fast fall of mud/debris material along a moderate to steep slope (>40°). The trend of the failure plane is N50°E/40°due SE and the failure mechanism is shallow rotational. The surrounding area of the landslide exposes with phyllite of Rangit pebble slate Formation of Gondwana Super Group covered with debris in fine matrix. Some parts of the affected area are also having forest land along with some settlements.</i></p>
