Inspection note on the recent visit to Machong Landslide, Pakyong, East District, Sikkim on 12/07/2017

Geological Survey of India, North-Eastern Region, State Unit: Sikkim, Gangtok

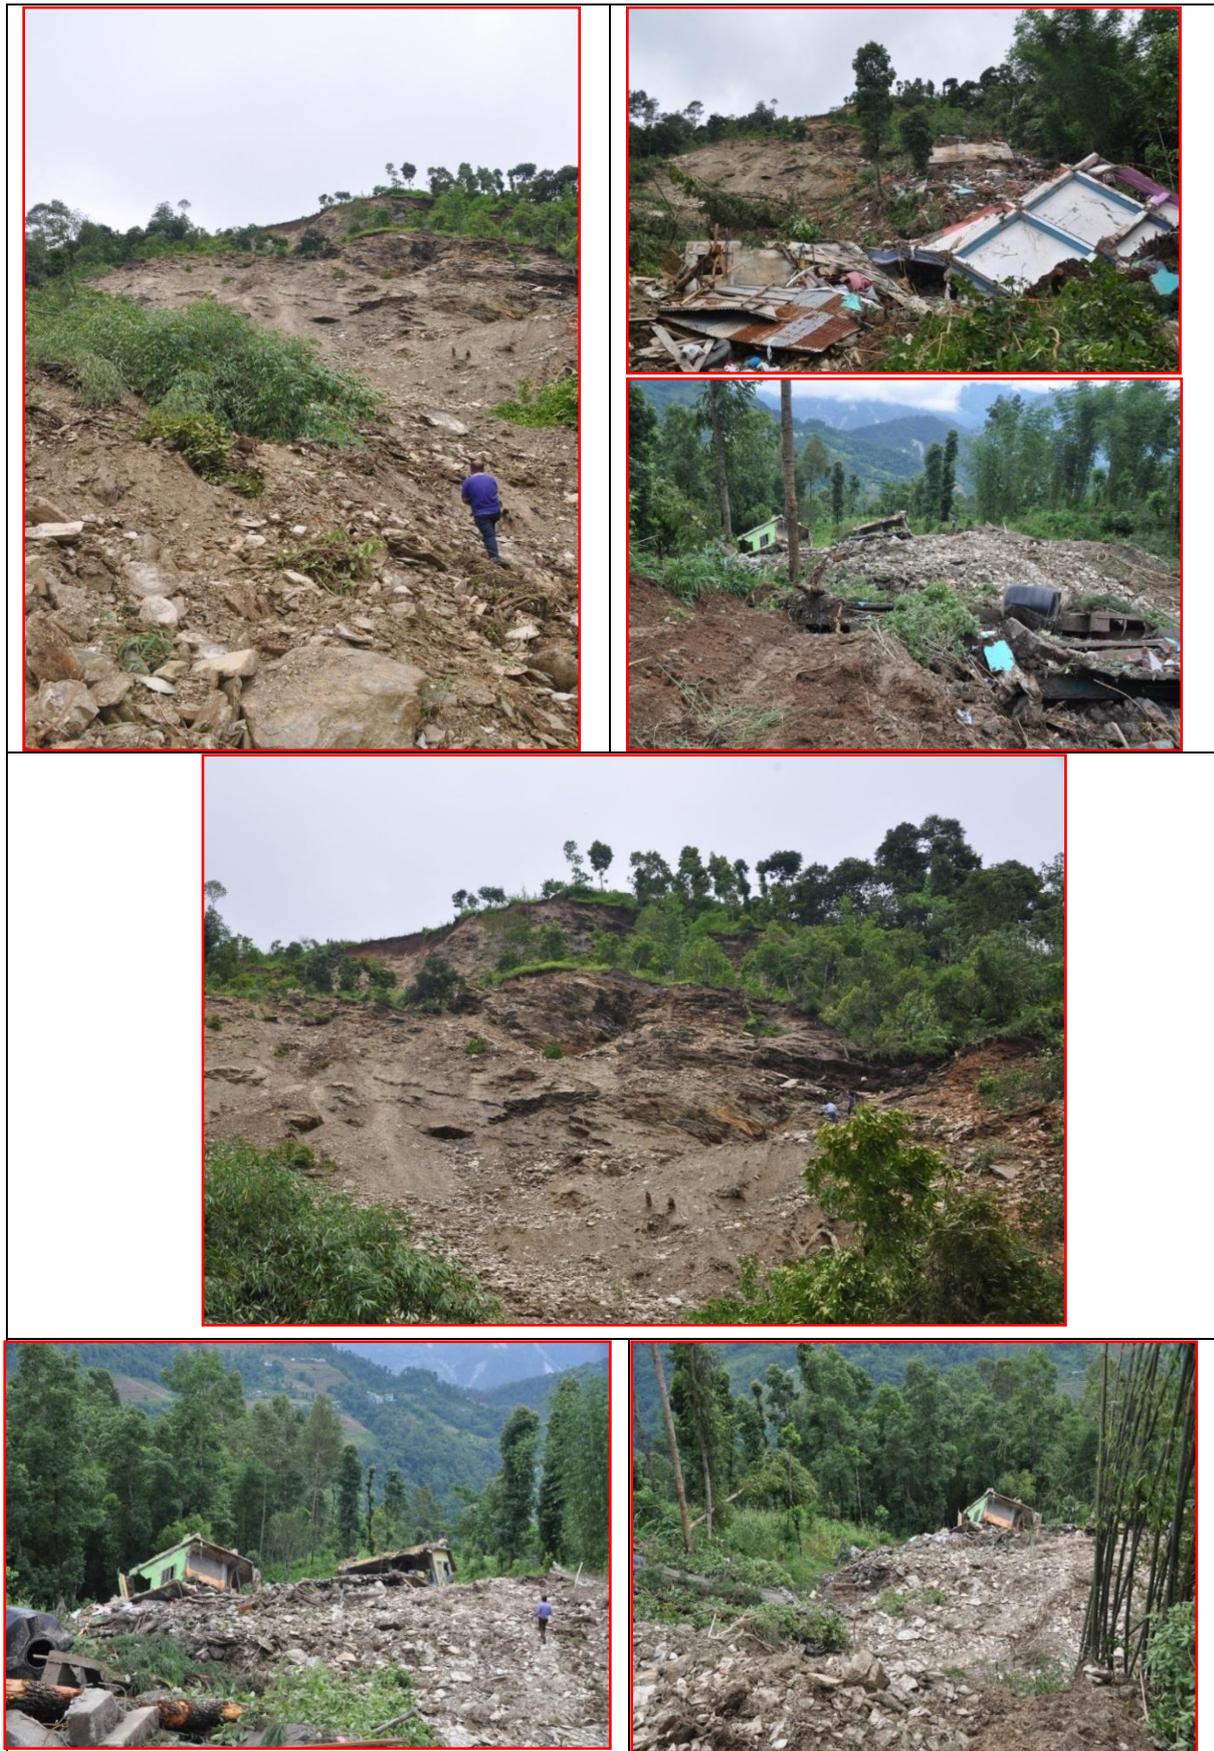
Preliminary field observation confirmed that the Machong landslide was characterised by a very rapid sliding movement along with fast fall of bedrock material along a steep slope ($>45^\circ$; refer Fig. 3), due to the action of gravity, which resulted accumulation of huge amount of rock debris. The dimension of this landslide is huge, having length of about 200m, width of about 120-150 m, height of about 100m, total run out distance of about 200m. The depth to failure surface being more than 5 m (deep seated). The landslide is enlarging in nature so far as its distribution is concerned. Observing the nature of movement, rapidity and material moved, this landslide can also be termed as rock fall/slide, which are quite common mostly in higher altitude areas of the Himalayas. During the active movement of this landslide, the failing landslide also generated a huge impact of moving rock boulders and a relatively moist debris. The type of overburden is highly weathered rock and soil having thickness of 1-3m. The rocks are highly fractured. A prominent discontinuity surface, probably a continuous joint plane has also been observed. The landslide is active, enlarging, multiple and deep translational in nature. The surrounding area of the landslide exposes with phyllite intercalated with quartzite of Daling group of rocks having the following trends: Foliation: $N50^\circ E/58^\circ \rightarrow SE$, Joint Planes [F1: $78^\circ \rightarrow 28^\circ$, F2: $52^\circ \rightarrow 315^\circ$]. Geomorphologically the affected area was moderately dissected with moderate vegetation. Some parts of the affected area are also having agricultural land along with some settlements.

Fig. 1: The Machong Landslide, East District, Sikkim.

Since during the present site visit, the landslide was active and movement of material was going on intermittently, thus, close observation of its zone of depletion area can be planned at later stage. The tentative geoscientific reasons of this landslide as observed could be i) wedge failure, ii) heavy rainfall, iii) local shearing/ fracturing rendering poor quality of rock mass, iv) pore water pressure developed in open fracture surface v) steeper slope morphometry. During last few days there had been significant rainfall in the area. Hence, pore water pressure developed due to long saturation of antecedent rainfall could have played a pivotal role in triggering this massive landslide.

This landslide swept five buildings along with vehicles leaving a trail of destruction but fortunately no casualties took place despite the large scale of natural calamity. The landslide has also endangered several nearby houses as well. The landslide is likely to reoccur as cracks have developed in the hill above the road. The landslide has washed away a portion of the Pakyong-Machong Road that snapped the connectivity between Pakyong and villages like Pachey, Linkey and Machong. The water supply line to Nopgaon and Pakyong town has been breached due to the landslide.

Since the landslide is still active and intermittent movement of rock material is also observed, the entire zone of accumulation area needs further investigation. During the current site visit, it was observed, that there is an accumulation of debris, formed due to this landslide. Field observation shows that huge material has already been mobilised due to this slide and rock along with debris have already moved out from its active zone of depletion (natural hill slope) and chances of similar type of major sliding activity in the vicinity area seems lesser. Although, the possibility of minor sliding activities in the rainy season cannot be ruled out.
