NOTE ON POST-DISASTER GEOLOGICAL STUDY OF THE LANDSLIDE AT NH-37, NEAR KOTLEN VILLAGE, MANIPUR

Project Landslide, GSI-NER, Dimapur

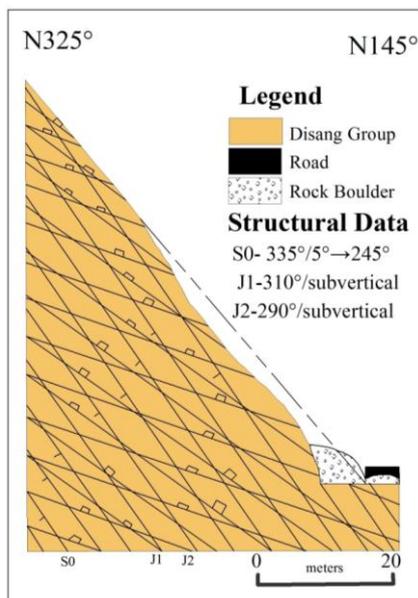
L-Section of landslide

Based on the disposition of the slide material as well as the visually estimated overburden thickness, a planar slide along secondary developed interface has been interpreted towards the up side of the landslide body. The primary triggering factor of the landslide is the rainfall. During the field study, it has been interpreted that the landslide has occurred due to combination of following factors

1. The bedrock is highly weathered wherein nearly 2-5 meters thick weathered rock is developed.
2. Unscientific slope cutting along the major joint plane is the main cause of the landslide. Due to cutting slope have become more than 60° which are above angle of repose. So the slope has become unstable due to this cutting and any triggering factor may lead to landslide.
3. After heavy rainfall the weathered rock absorbed huge amount of water which led to the decrease in the shearing strength of the material and it slid down.

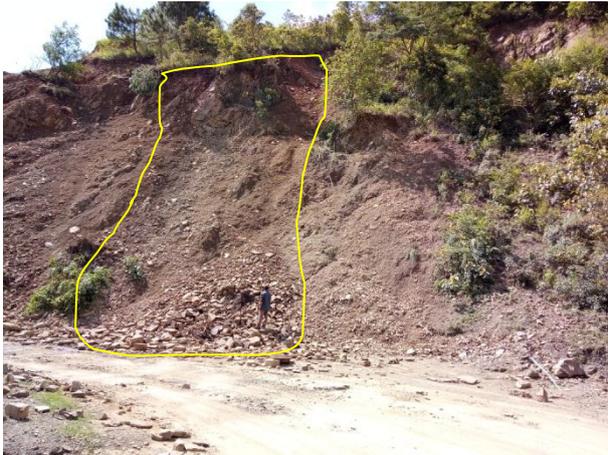
Photo 1: Landslide on NH-37

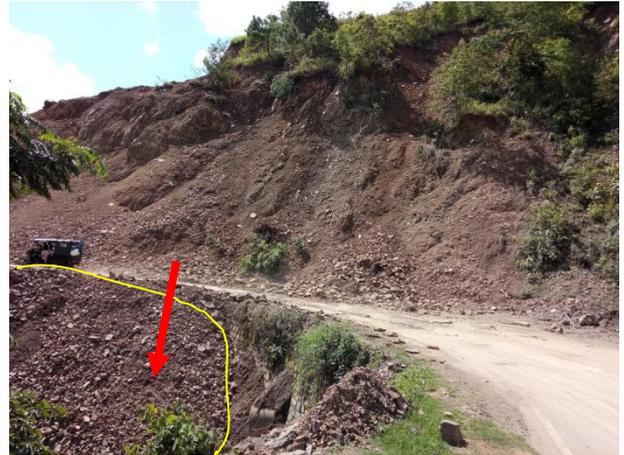
Photo 2: Run out material.

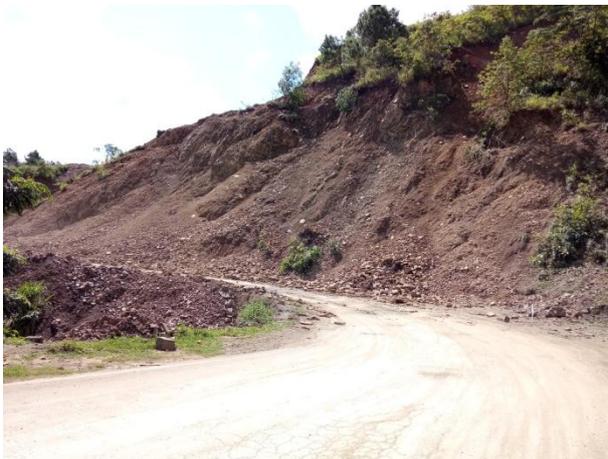
Photo 3: Weathered rock

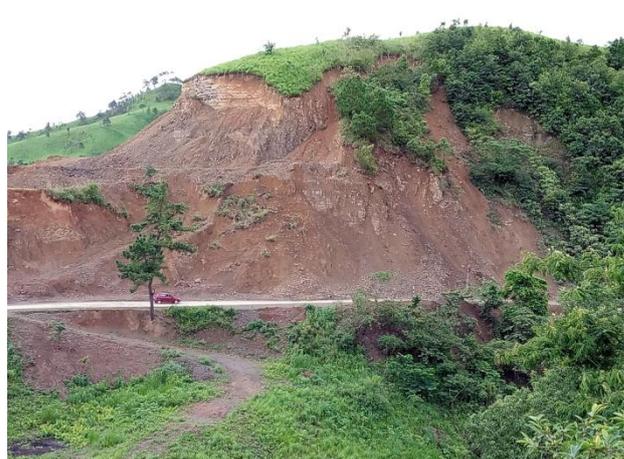
Photo 4: View of landslide from distance.

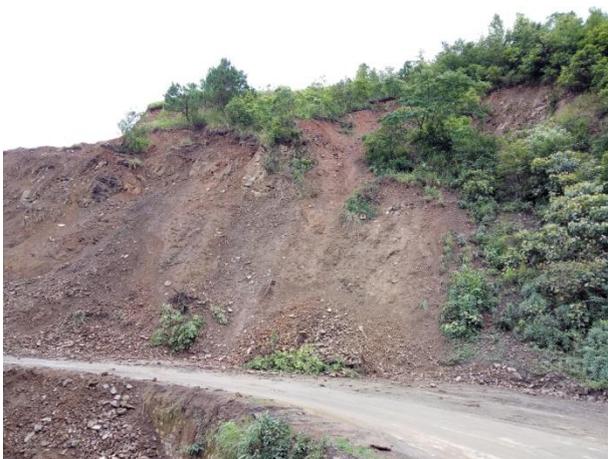
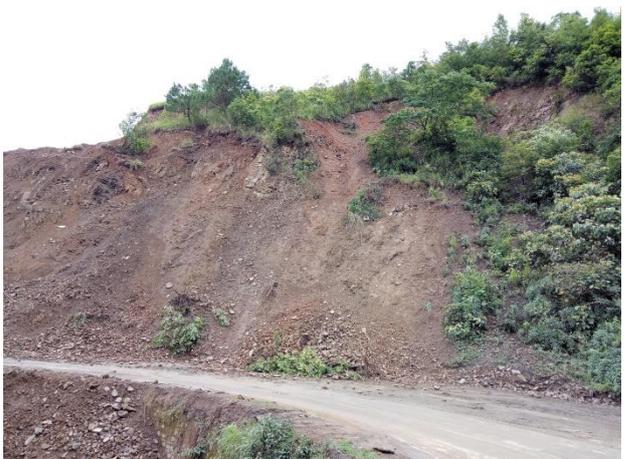
Photo 5 & 6: Extensive slope cut
