**NOTE ON POST-DISASTER PRELIMINARY GEOLOGICAL STUDY OF THE
LANDSLIDE AT NH-102A, NEAR LEITING VILLAGE, UKHRUL DISTRICT,
MANIPUR**

Abhinab Borah, Geologist & Monotosh Mudi, Asstt. Geologist

Project Landslide, GSI-NER, Dimapur.

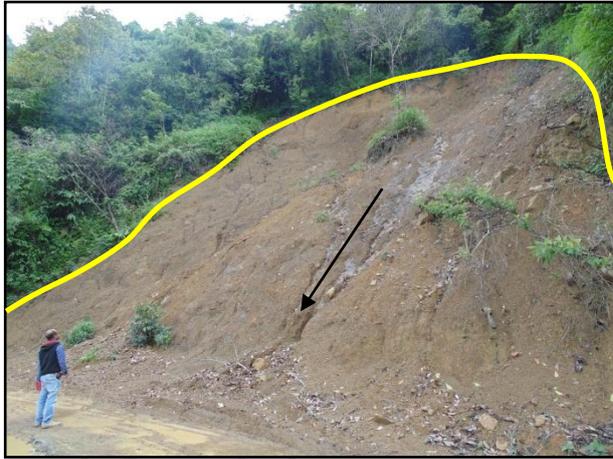
Photo 1: View from left flank of the landslide

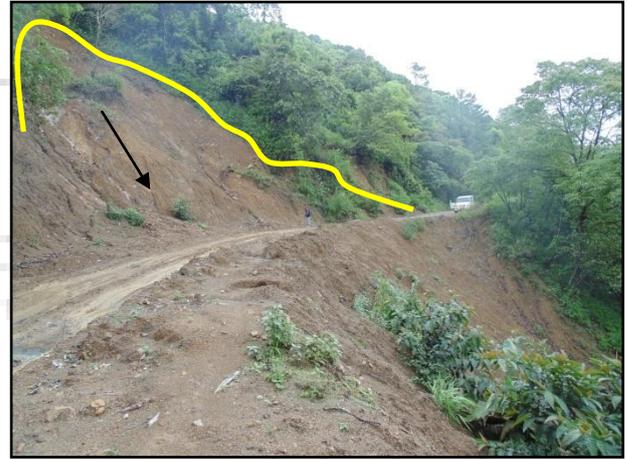
Photo 2: View from right flank of the landslide

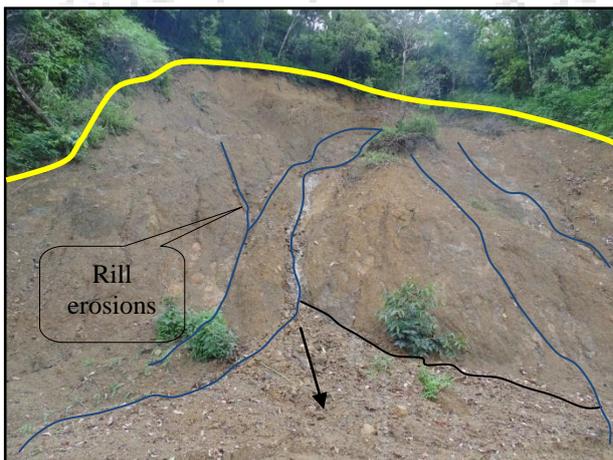
Photo 3: Front view of the landslide (Photograph taken in upslope direction)

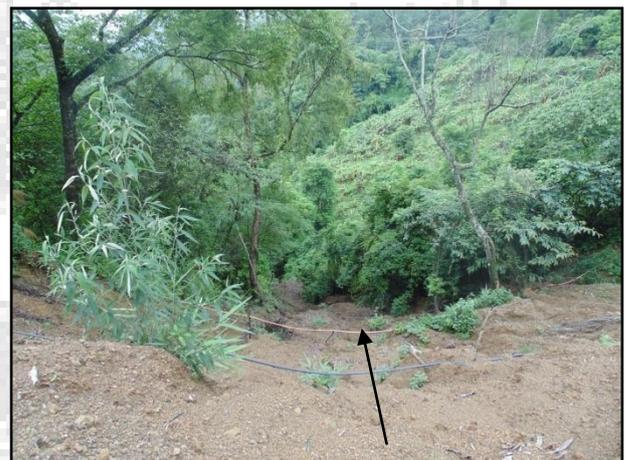
1. The rock exposed adjacent to this slide comprises thinly bedded shale and siltstone bands of Upper Disang Formation which represents a weak rock mass.
2. Lack of a lined hillside drain along the road leading to percolation of surface runoff into the weak rock mass.
3. Presence of unguided down slope flow of surface runoff.
4. The existing road is to serve for the local need of transportation from Ukhrul to Phungyar Village. The dumped material has been removed by the local authority.

Photo 4: Dumped materials of the landslide (Photograph taken in downslope direction)
