## **A NOTE ON THE POST DISASTER LANDSLIDE INVESTIGATION OF LUNGLAWN LANDSLIDE IN LUNGLEI TOWN, LUNGLEI DISTRICT**

**Priscilla Rinmuanpuii, Geologist  
SU: TM, GSI, Aizawl Camp Office.**

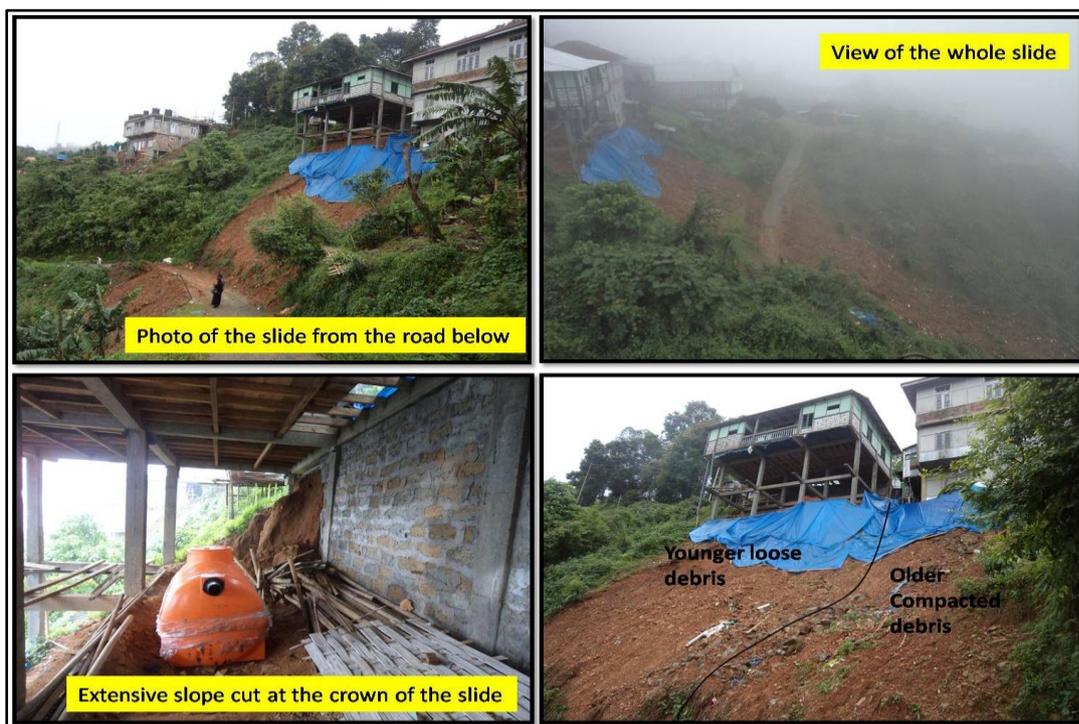
The particular slope on which the landslide occurred is covered by older compacted debris and 2 to 3m thick younger loose debris derived from extensive slope cutting and dumping of waste material during building of an older house on the right portion of the crown and a recent building on the left portion of the crown. The dimensions of the landslide are 15m length x 18m width x ~ 3 m depth.

The landslide crown is close to foundation of the buildings and the new building has thus become vulnerable. The landslide has also destroyed a part of the retaining wall meant to protect the foundation of the older building. Unfortunately the house below the landslide was located in the zone of accumulation and was completely buried by the debris material. The debris from the landslide also damaged about 20m of a footpath towards the toe of the slide.

1. The bedrock (Shale) is highly weathered, while the slope is governed by the dip of the bedrock which is  $40^\circ$  towards south-east direction.
2. There was extensive slope cutting at the crown of the slide during the construction of the building at the crown. The excavated materials were dumped on the steep slope without any retaining wall and just resting on the slope behind the house. The older house was also constructed by extensive slope cutting and dumping of excavated materials on the slope. However, the excavated material from the site of older building was more consolidated and these were used as fill material to develop a terraced kitchen garden with a retaining wall.

3. Continuous and heavy rainfall for one whole day caused extensive surface runoff which destabilized and triggered the movement of the loose, unconsolidated dumped wastes resting on the steep slope without any protection works.

Fig:1. Photos of various parts of the slide.

1. Keeping the above observations in mind, it is strongly recommended to provide a suitable retaining wall in the affected zone of nearly 20 m length to be founded preferably on the bedrock (Fig. 3) with proper weep holes at the toe of the landslide which will restrict the further movement of the slope material.
2. Lined contour and cross drains needs to be constructed in the area to effectively drain the surface runoff away from the affected zone and particularly along the road at the crown of the slide (Fig. 3).
3. Proper lined drainage and pipes to guide domestic run off and runoff from the roofs of the houses to avoid further damage to the foundation on the backside of the houses.
4. Slope easing by construction of benches with proper retaining and breast wall on the affected slope with adequate drainage arrangement.

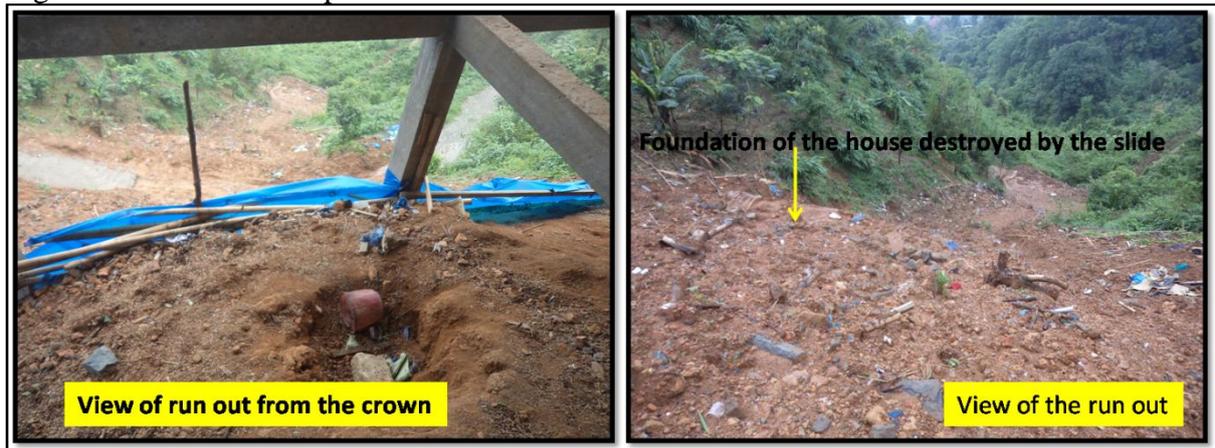
Fig:2. Photos of the run out of the landslide.
