Inspection note on the recent visit to Syari Landslide, Deorali, Gangtok, East District, Sikkim

Geological Survey of India, North-Eastern Region, State Unit: Sikkim, Gangtok

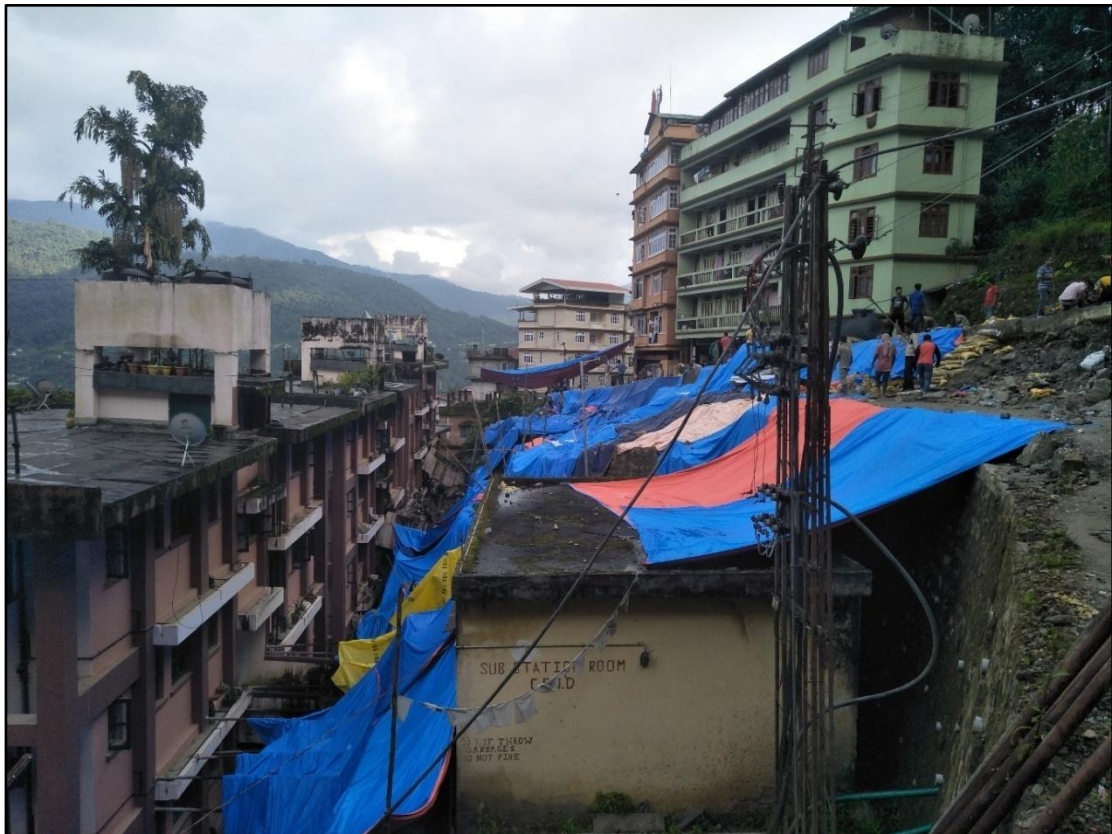
Preliminary field observation confirmed that the Upper Syari landslide was characterised by a slow movement along with fall of debris material along a steep slope ($>45^\circ$), due to the bulging and action of gravity. This resulted in the accumulation of huge amount of debris just behind the AG residential complex. The dimension of this landslide is small, having length of about 80 m, width of about 150 m, height of about 60 m, total run out distance of about 100 m. The depth to failure surface being more than 2 m (deep seated). The failure is debris slide, which are quite common in Himalayas. During the active movement of this failure, a huge impact of moving rock boulders and a relatively moist debris have been created on the residential buildings. The type of overburden is weathered and unconsolidated rock and soil having thickness of 1-2m. The rocks are highly fractured. The failure has been initiated with the appearance of cracks which subsequently enlarged. There is excess overburden pressure, which resulted in bulging and failure of slope material. Geomorphologically, the affected area is lowly dissected with sparse vegetation. Some parts of the affected area are also having agricultural land along with heavy settlements.

Fig 2: The affected slope due to failure in Upper Syari.

This failure damaged buildings, roads, water supply line and power supply lines but fortunately no casualties took place. A proper heavy load bearing gabion wall along the slope is required immediately to hold the overburden material and to keep the buildings safe. Proper drainage is essentially required to avoid any other failures.

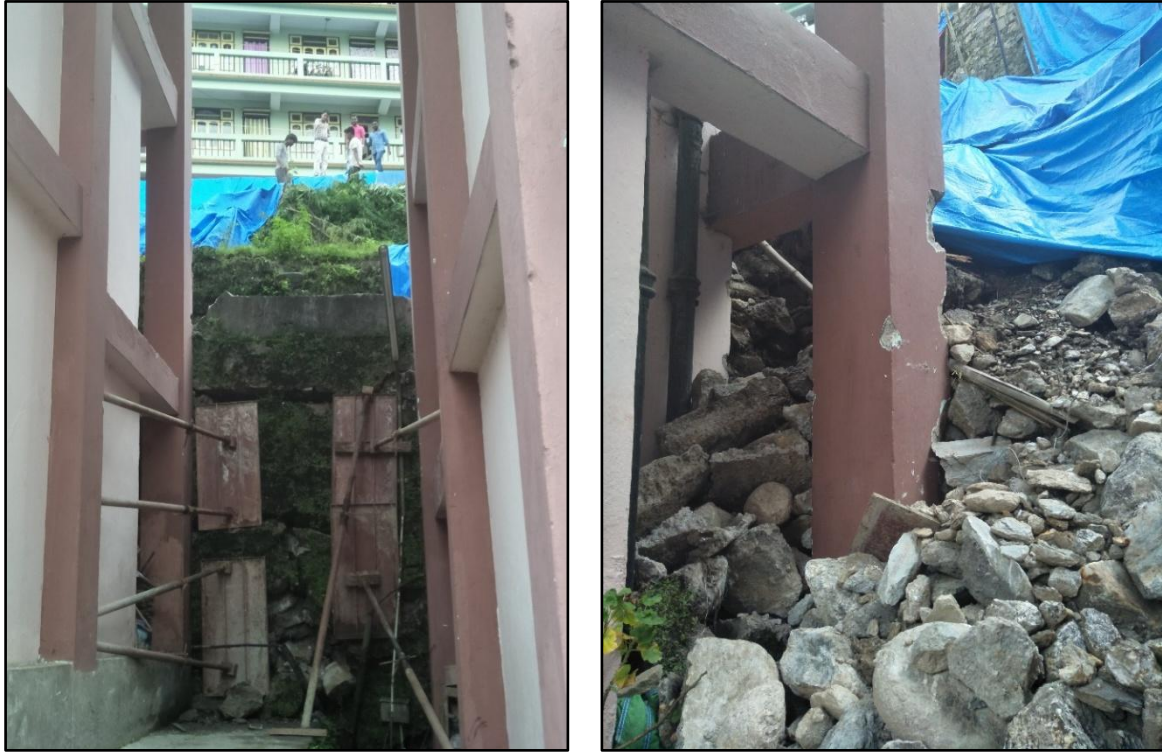
Fig. 3 & 4: The failure affecting the slope and the buildings in Upper Syari.
