Inspection note on recent visit to the JNM Axis Road at Mile Stone-8:

1st BN Sikkim Scouts

Geological Survey of India

SU: Sikkim, NER, Gangtok

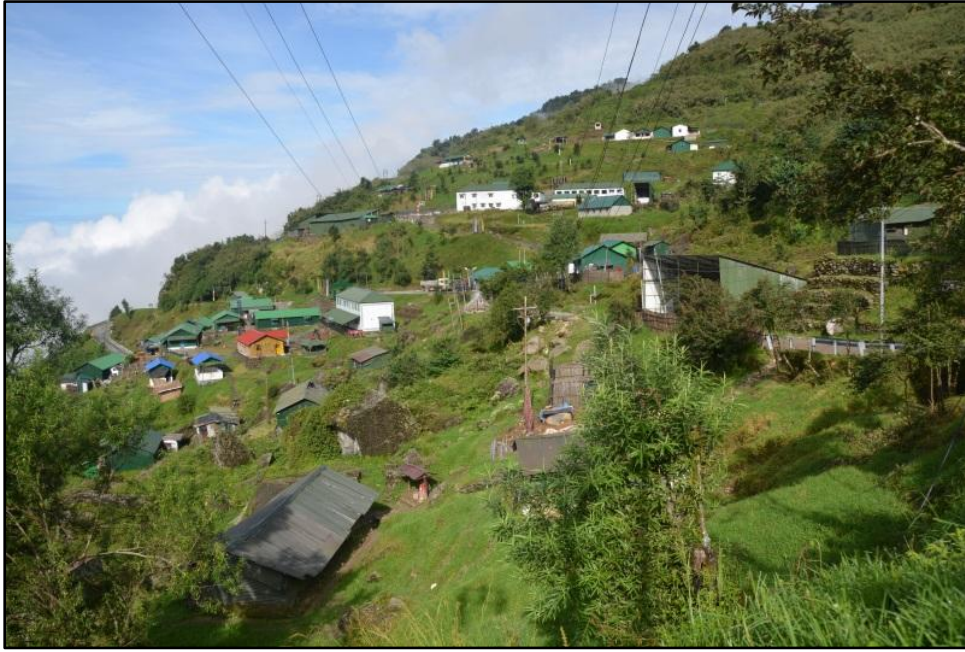
Field visit was made on 16th August 2018 and preliminary report on the observation made in the area between unit location of 1st BN Sikkim Scouts and the road stretch (JNM axis) ahead of MS-8, suggests that the area mainly lies on a slope which appears to be a major “paleo-landslide” (Fig. 1). The area around unit location of 1st BN Sikkim Scouts and the road stretch (JNM axis) ahead of MS-8, belongs to Kanchanjunga gneiss / Darjeeling gneiss of Central Crystalline Gneissic complex. However, in-situ rocks were nowhere observed in the entire studied area. The field observation when analysed along with the Google imagery and topographic map of the area shows that the area is dissected by major drainage lines i.e. D1, D2, D3 & D4 (Fig.2). Major evidences of subsidence were mainly observed between drainage line D1 and D2, running roughly parallel to the streams. Recent landslide has been observed between D2 and D3, which has interrupted the traffic on strategically important Gangtok-Nathu La road. The area exposes unsorted and unconsolidated debris material consisting of big and giant boulders, as clearly observed in the road widening going ahead of MS-8 (Fig.3). The stream path along D1 is marked by presence big boulders (Fig. 4). Majority of the field evidences indicative of active subsidence in the form of cracks developed in the culvert, floor, or roads show vicinity to drainage line D1 and D2 or lies in the area between drainage line D1 and D2 (Fig. 5). However, to the west of D1, at present no significant subsidence activity was noticed except some tilting of plants along the road side, which was not seen in the plants on the upper slope. It was also observed that the water flowing along the drains was also muddy, indicating that the fines present in the debris material of the paleo-slide are being rapidly dissolved making the area more unstable.

Fig. 1. Rolled boulders in the camp area located over paleo-slide.

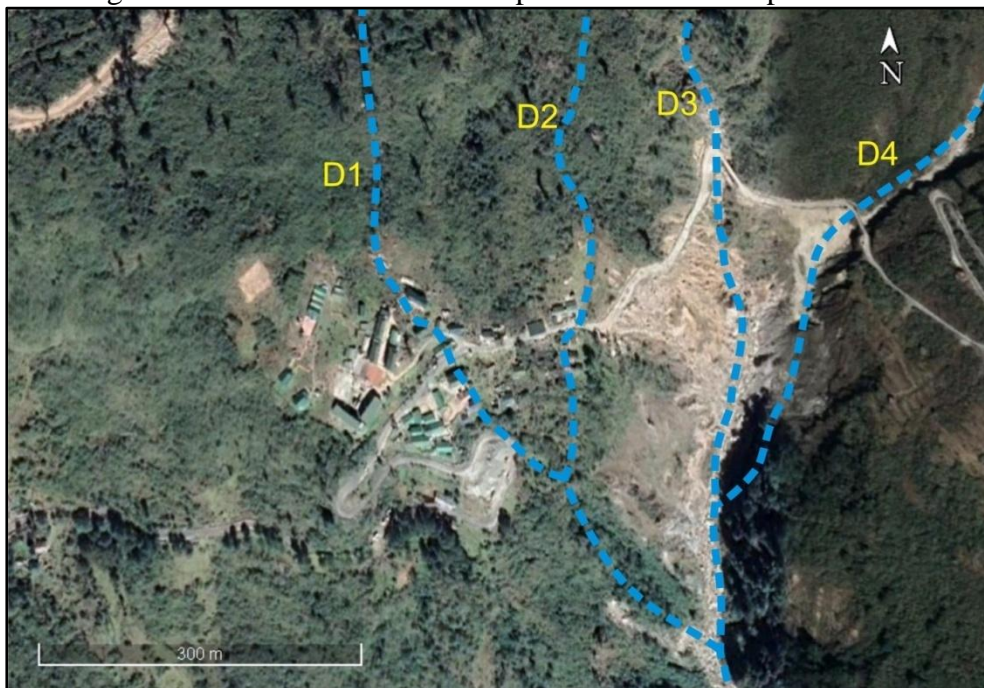
Fig. 2: Perennial streams passing through the camp area of 1st BN Sikkim Scouts and the road stretch (JNM axis) ahead of MS-8 (Shown over Google Image).

The present unit location of 1st BN Sikkim Scouts lies on both sides of D1. The establishment to the eastern part of D1 needs immediate evacuation. However, the establishment on western side of D1 can be maintained with proper support to the slope by constructing Gabion wall in steps with maintaining a safe distance of about 10m from stream D1. This will arrest the loss of solid particles being drained in the streams, especially in D1.

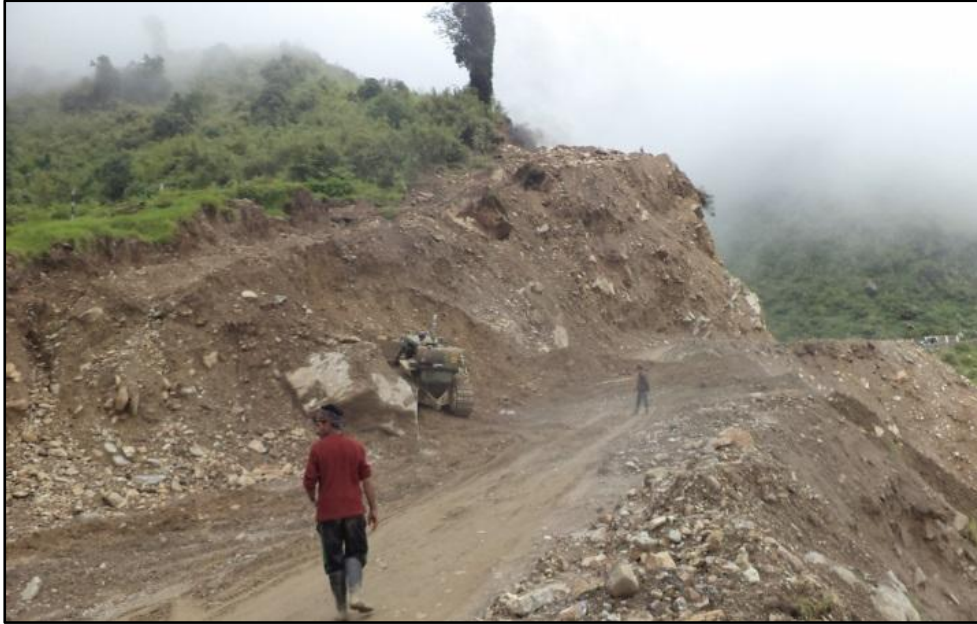
Fig. 3: Unsorted and unconsolidated debris material exposed along the road cutting (JNM axis) ahead of MS-8.

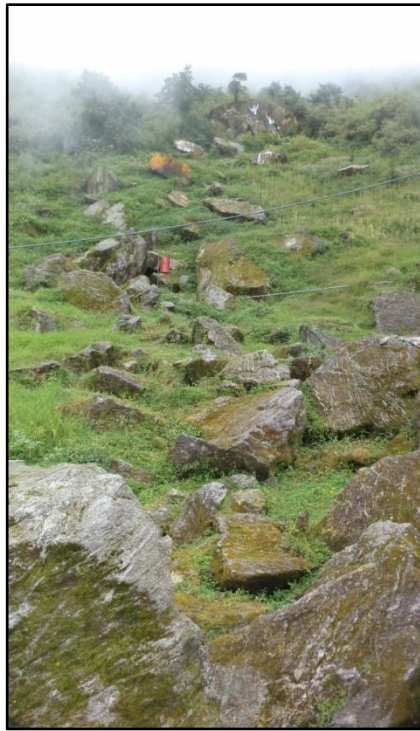
Heavy rainfall in the area might have increased the flow along the old drainage lines present in the area, which otherwise may not be so prominently seen due to debris cover/big boulders present along its path (Fig.4). Percolation of water in between D1 and D2 in the paleo-slide zone may have activated the subsidence activity in the area. On the basis of preliminary observation it is suggested that the area between drainage line D1 and D2 is not at all suitable for habitation. Although the area to the west of drainage line D1 is also a part of the same paleo-slide, but at present do not show any significant evidence of subsidence.

Fig. 4: Rolled boulders covering the path of stream D1.

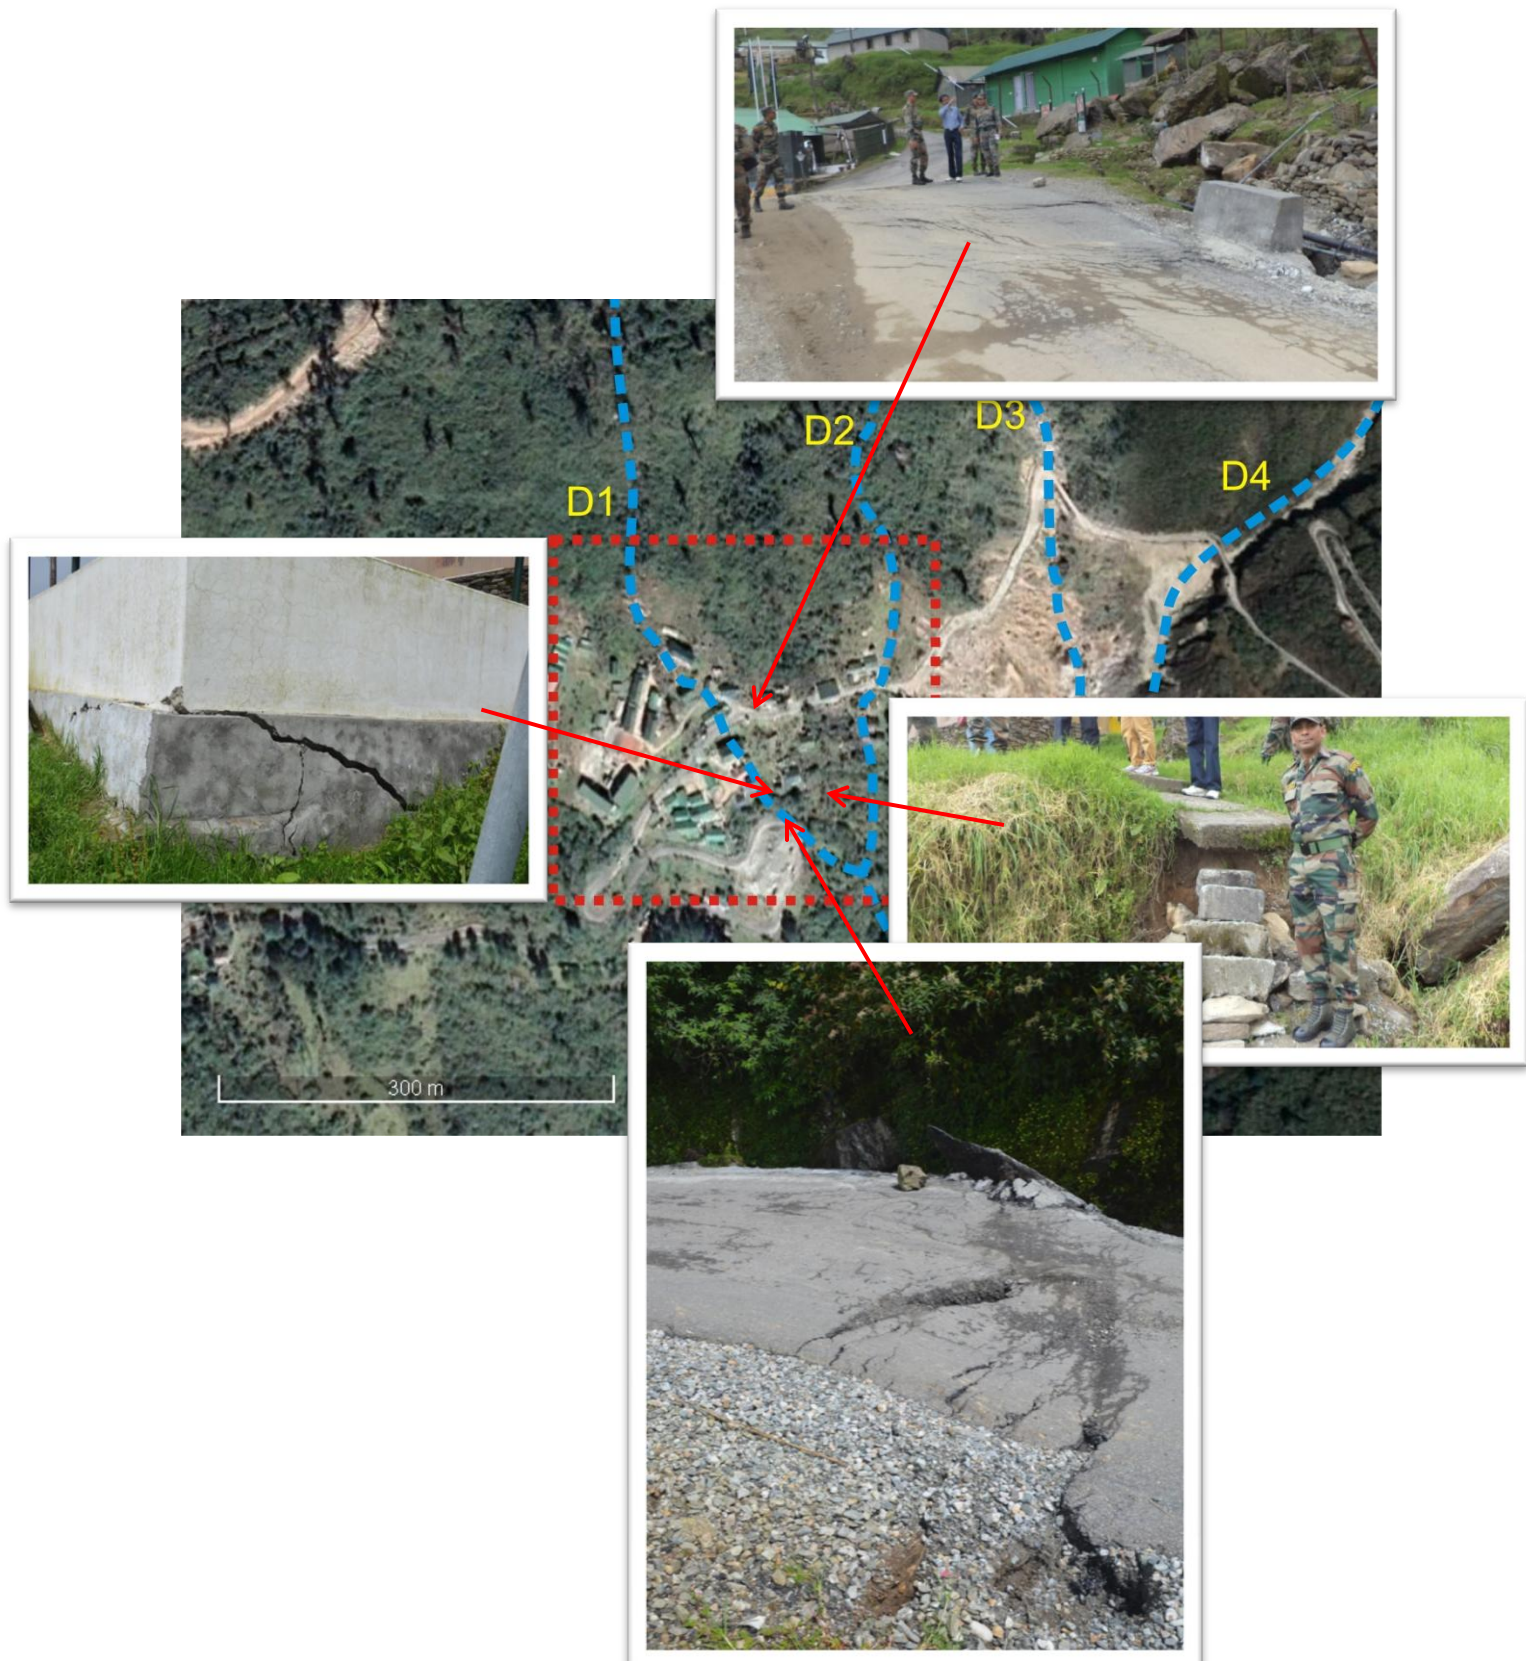
Fig. 5: Photographs showing disposition of surface evidences of active subsidence in the form of cracks developed in the culvert, floor and roads.

37	Remedial measures	<i>Evacuation from the area lying in between the flowing streams, making arrangement for proper drainage and diversion of flowing stream, erecting gabion wall</i>
38	Remarks, if any	<i>Cracks appeared on the road and along the settlement.</i>
39	Photos. Sketch of Plan & section of the slide	<i>Attached with note.</i>
40	Summary/Abstract	<i>Attached with note.</i>
41	Pdf	<i>Attached</i>
42	Landslide Category	<i>Type.....</i>
