**PRELIMINARY POST DISASTER STUDY OF THE LANDSLIDE AT KIKRUMA
(ON LEFT BANK SLOPE OF SIDZU RIVER), PHEK DISTRICT, NAGALAND**

Project Landslide, GSI-NER, Dimapur

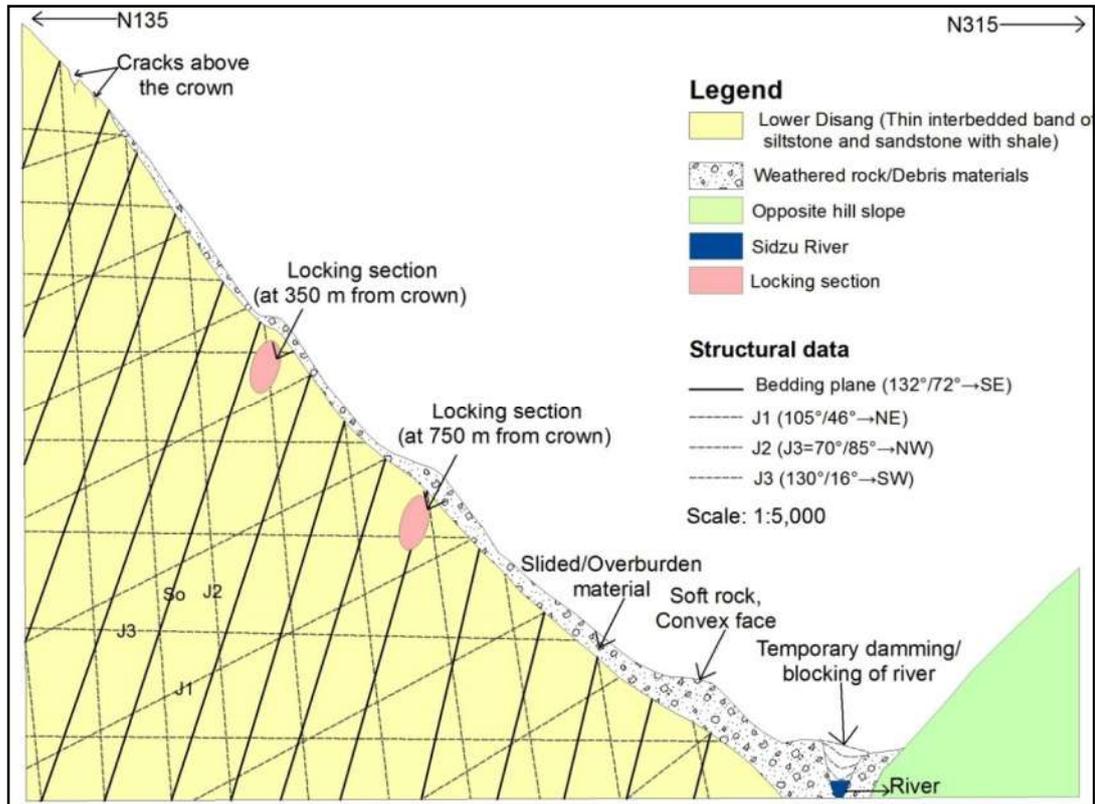
Fig.1: L-section of the slide.

permeability difference with the slope base because of permeability difference. There is a chance of movement of water along this surface parallel to the slope. This acts as a sliding plane for the overlying material to slide down the slope. This indicates a deep translational failure.

A longitudinal section along the length of the slide is prepared (1:5000) to delineate shape of the slide and disposition of slided material along the length of the slide. Trend of section line is 315° - 135° (slide direction 315°).

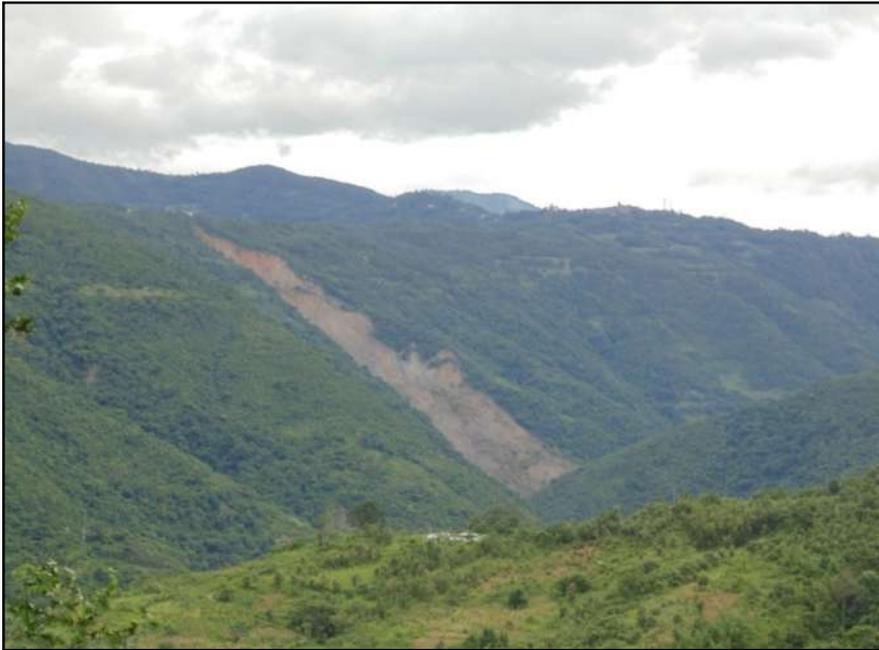
Fig 2: View of the Kikruma slide from Chakhabama side.

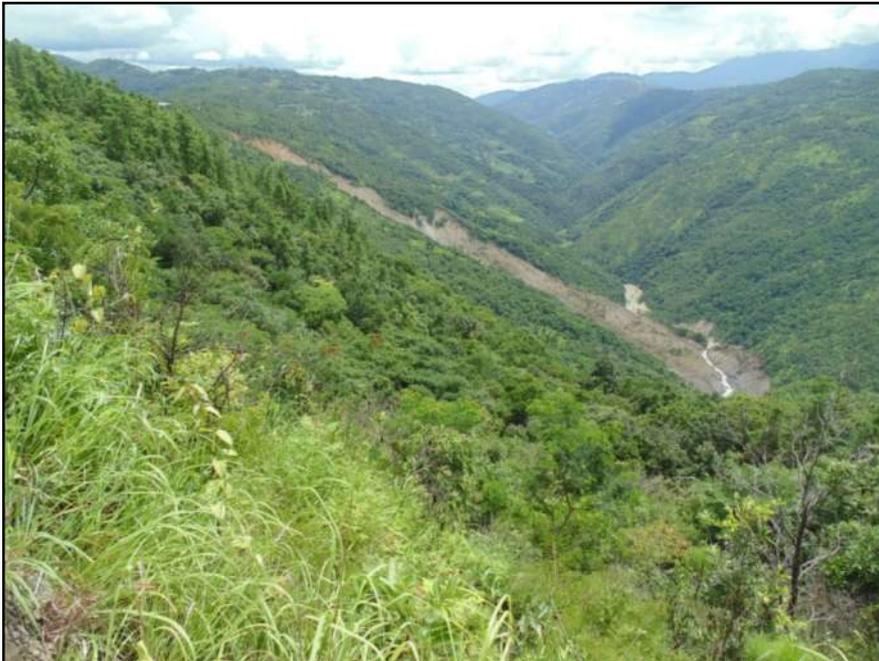
5. The material has slid down and formed an artificial dam of height about 20m along the narrow valley across the river. The water flow was arrested due the damming, creating an artificial reservoir. However when the water level rose to the top of the dam it started eroding the material and subsequently dam was washed away. Due to

Fig3: Photograph showing the remnant part of artificial dam on the Sidzu River.

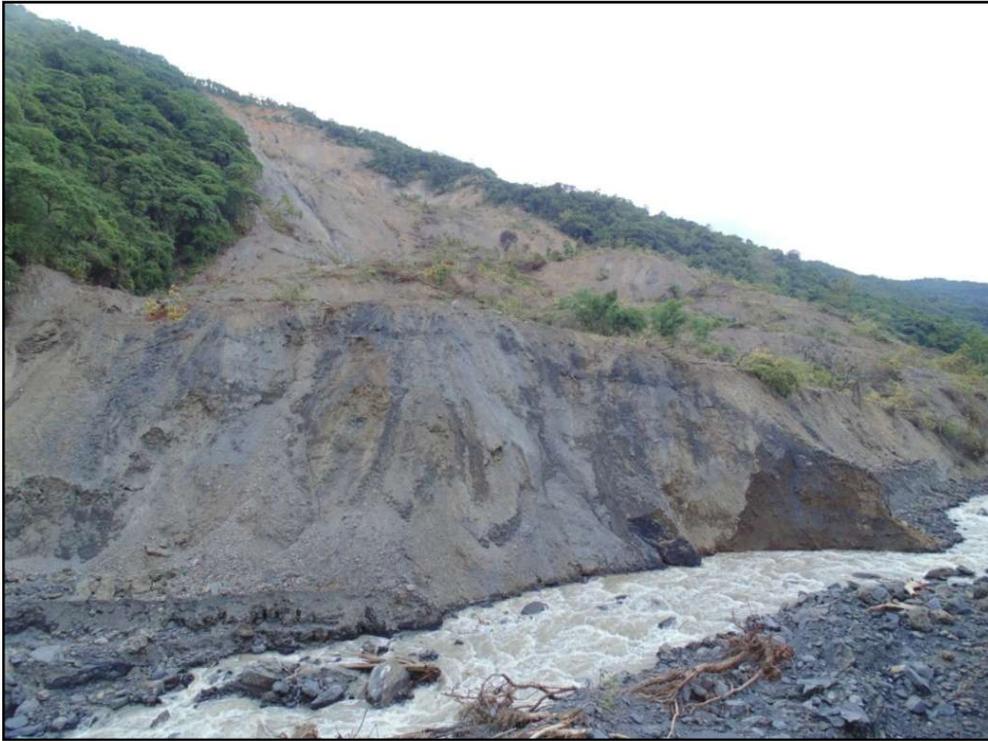
Initiation of the slide occurred due to toe cutting by the rising water level in the Sidzu river and gradually retrograded towards up slope. Bedrock comprises highly weathered shale of Lower Disang Formation. The rocks of the area are also highly jointed and sheared rendering a poor rockmass condition. Geologically, weathering of Disang shales gives rise to clay-rich overburden/soil. Such soils with significant porosity but low permeability lead to development of groundwater (pore water) pressure that has acted to destabilize the slope further, in this case. The overburden thickness is as high as 2-5m. Overburden consists of weathered shale fragments embedded in argillaceous matrix. The saturation of the overburden material by antecedent heavy rainfall contributed to the weight of the material, increasing the resulting downward force. The slope mass creates an imaginary surface of

Fig 4: Photograph of the toe of the slide.

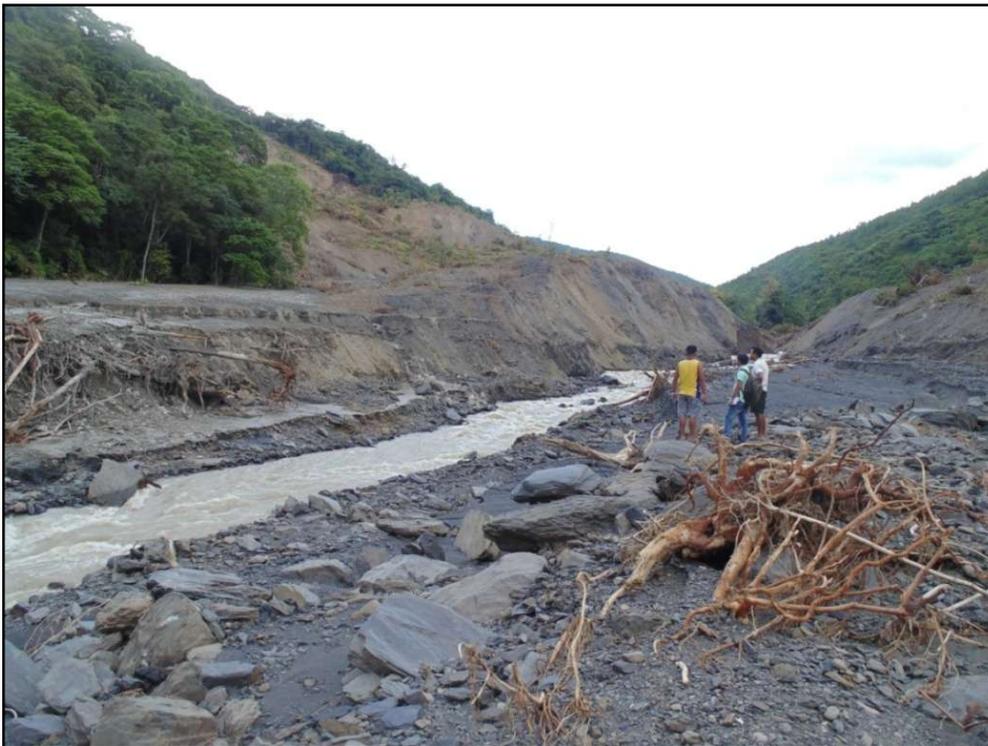
the sudden bursting of that dam, huge amount of water along with the slided material flowed down the river and deposited huge debris along its course up to a distance of 300m. This debris engulfed many paddy fields along the downstream side.

Fig 5: Photograph showing slided material deposition along the downstream of the river.

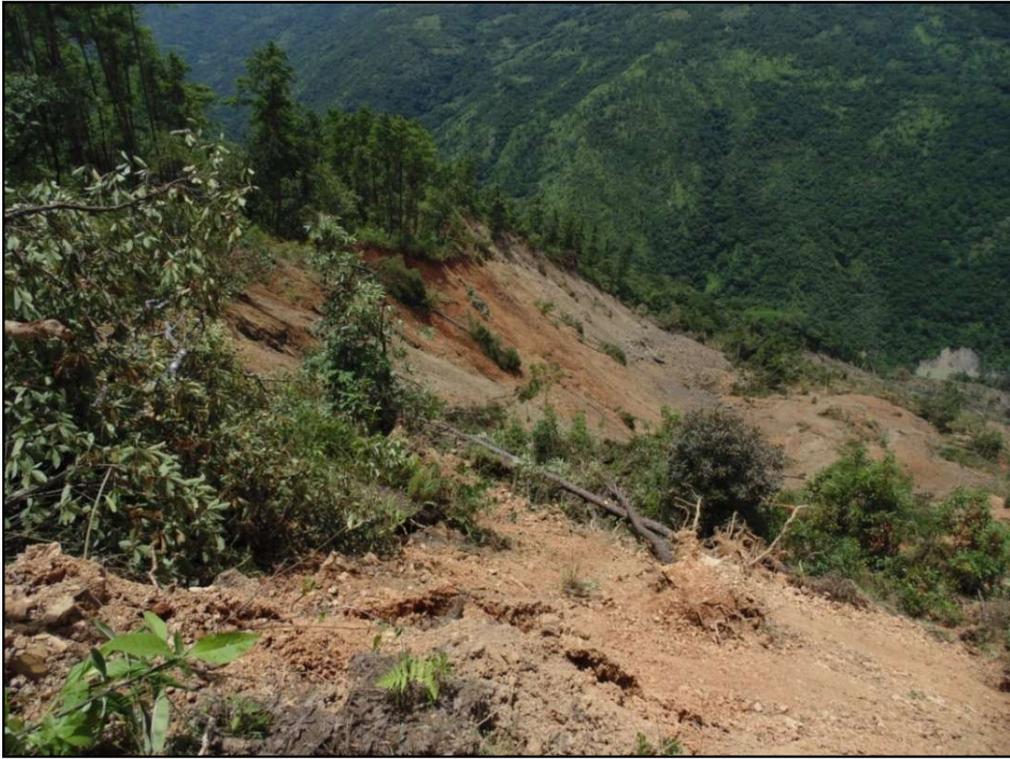
Fig 6: Photograph taken from the crown of the slide showing the scarp faces on the left flank.

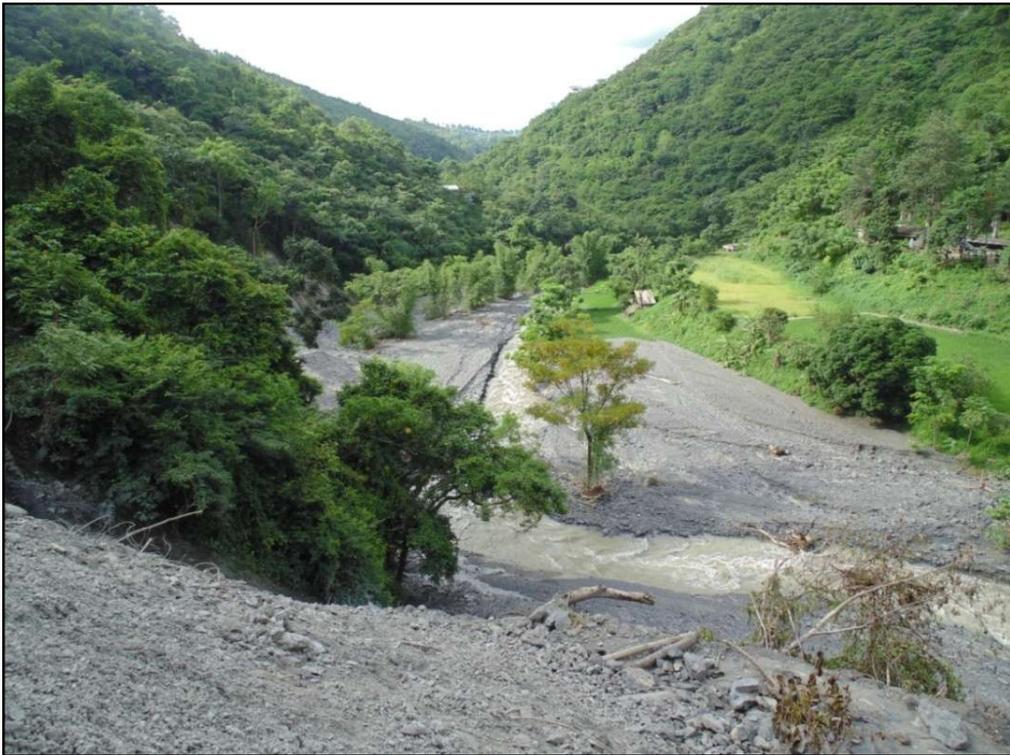
Fig 7: The run out material deposited over river terrace (paddy cultivation) causing the change in river course.

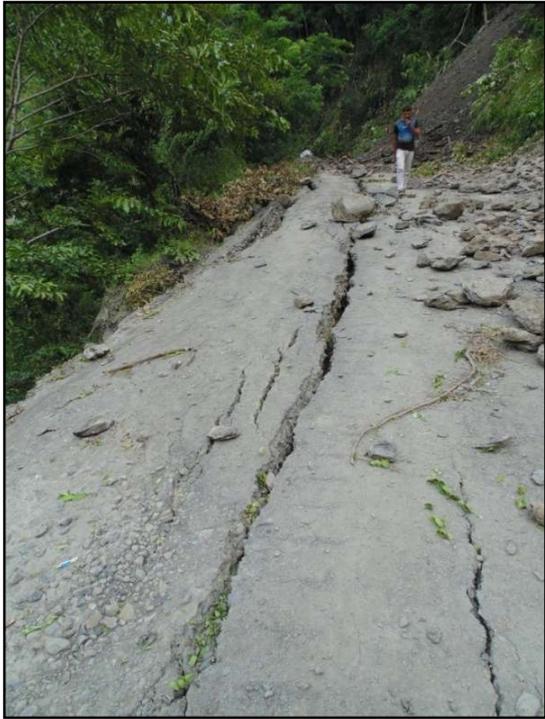
6. Due to sudden increase of volume of water by the breakdown of the dam, rate of toe erosion increased towards the downstream. As a result the road 150m away from the slide was severely damaged and 50m of the road has completely slid down and another 100m was partially slid and longitudinal cracks were developed. To rehabilitate the communication, Border Road Organization has started construction of new alignment of road along the affected part by back cutting of the hill slope.
7. A bridge on the Sidzu River was affected due to breach of the dam where rising water level eroded the abutments of the bridge.
8. The increased water volume and current velocity caused change in previous river course.
9. The rocks in the area are highly sheared. Second generation folds were observed. Folds are shallow plunging towards SSE.

Fig 8: Formation of longitudinal cracks along the road due to subsidence caused by toe erosion.

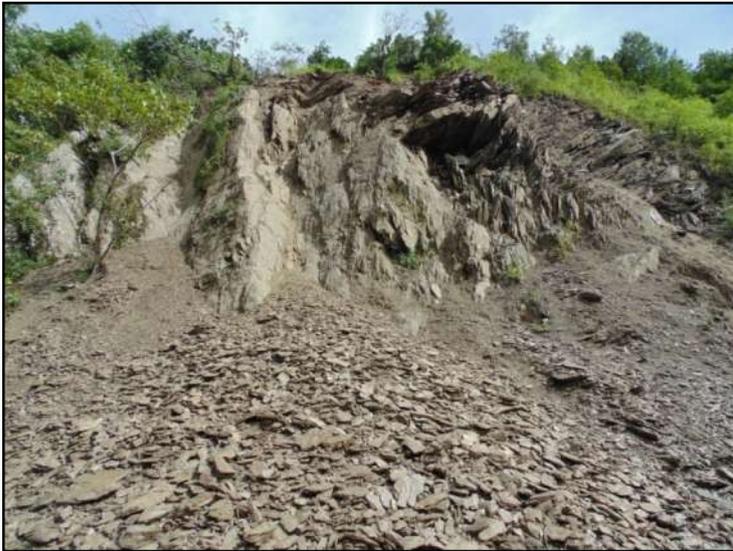
1. The affected slope consists of weathered shale of Lower Disang Formation. Overburden thickness ranges from 2-5m.
2. The rocks are highly jointed. Three sets of prominent joints are recorded.

Fig 9: Highly sheared, jointed, partly metamorphosed and folded rocks of Lower Disang.
