**A NOTE ON PRELIMINARY GEOTECHNICAL INVESTIGATION FOR  
CONSTRUCTION OF POURKARMIKAS QUARTER / HOUSES UNDER THE  
“POURKARMIKAS GRUHA BHAGYA SCHEME” AT MADIKERI, KODAGU,  
KARNATAKA**

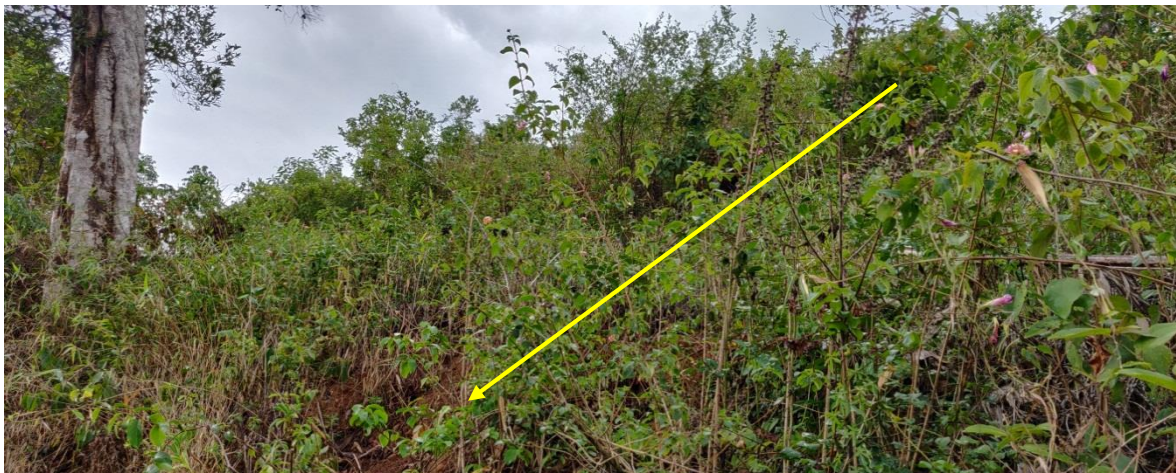
The site is located near Karnangeri village, Madikeri Taluk adjacent to Sudharshan guest house, Madikeri. The site is moderately undulating in nature with general slope varies from 35° - 40°. Geologically the area comprises of highly weathered granite gneiss and the overburden thickness of the area is relatively high (5 – 7 m). There are no landslides or surface cracks present within the site or along the peripheral part of the site. One prominent 1<sup>st</sup> order stream with the flow path towards south western direction is present within the site. The 1<sup>st</sup> order stream along north eastern peripheral boundary of the site is partially filled with some dumped materials (Photo – 2 & 3) which may block the stream in future resulting in initiation of slope failure. Moreover, the site is situated at the mid slope area of the hill slope. For any constructions in the mid slope area, cutting and benching of the slope is essential. Proper remedial measures must be adopted for the cut slope towards the upslope area and the toe of the bench towards the downslope area to avoid any slope failures in the future.

Photo – 1 View of the general slope of the site.

From all these observations made during preliminary feasibility study, the site is found to be geotechnically not suitable for construction of pourkarmikas quarter / houses. But it was informed to the GSI team that Detailed Project Report (DPR) for the site has already been prepared by some other agency. So, in case of any future construction, proper precautions and care must be adopted in cutting, benching and stabilization of the slope.

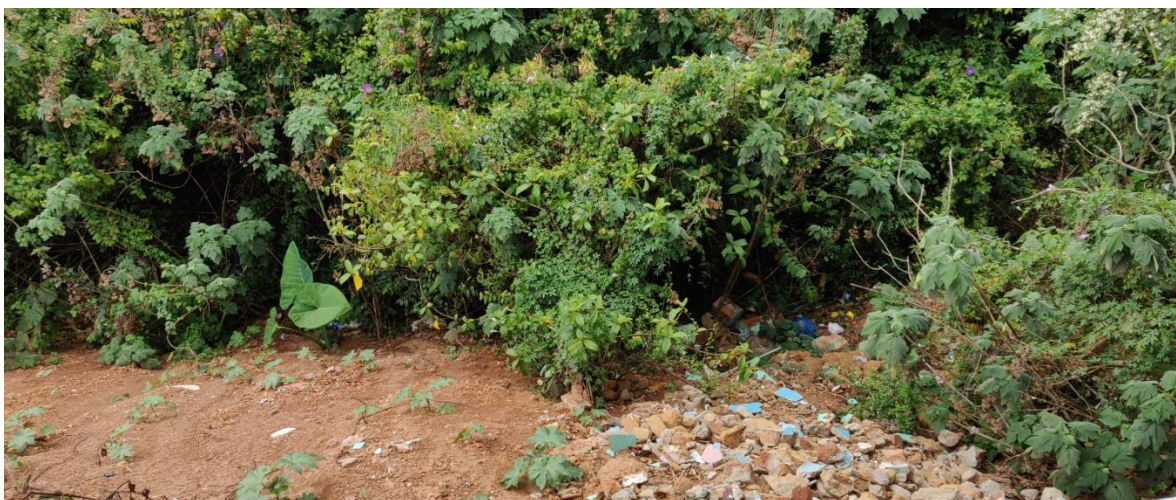
Photo – 2: 1<sup>st</sup> order stream at the site partially filled with dumped material in the north eastern peripheral boundary.

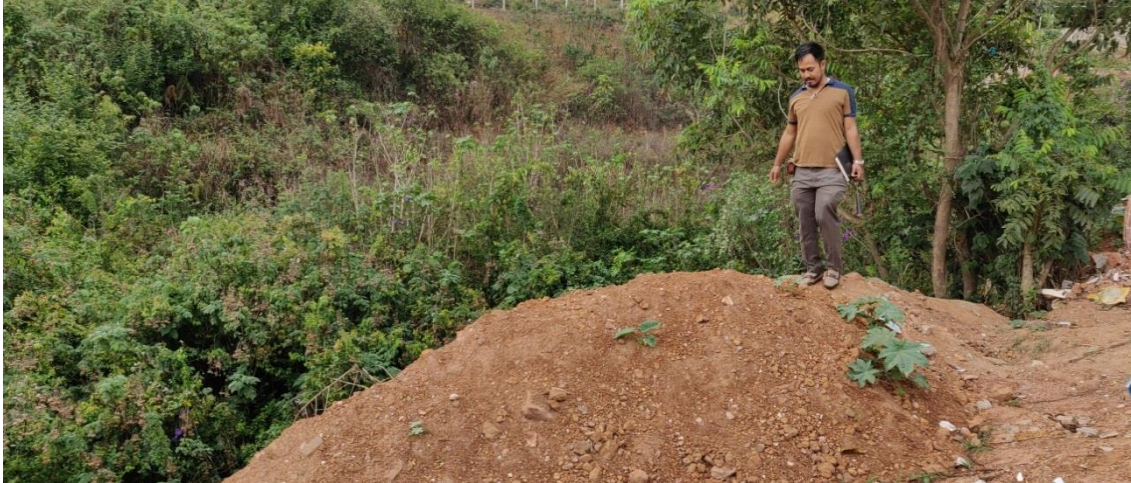
Photo – 3: View of dumped material along the north eastern peripheral boundary of the site.

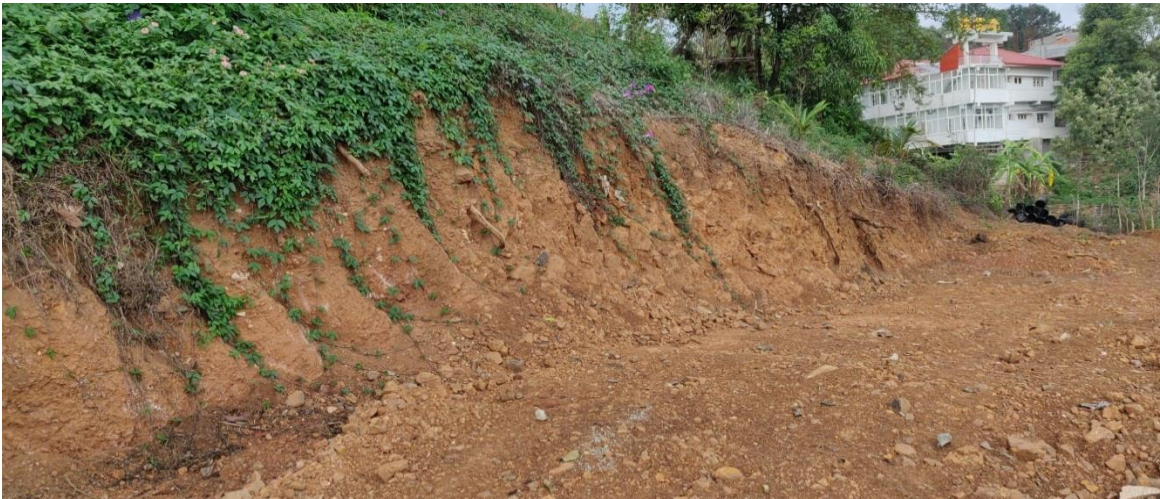
Photo – 4: View of weathered granite gneiss exposed at the top of the hill slope.

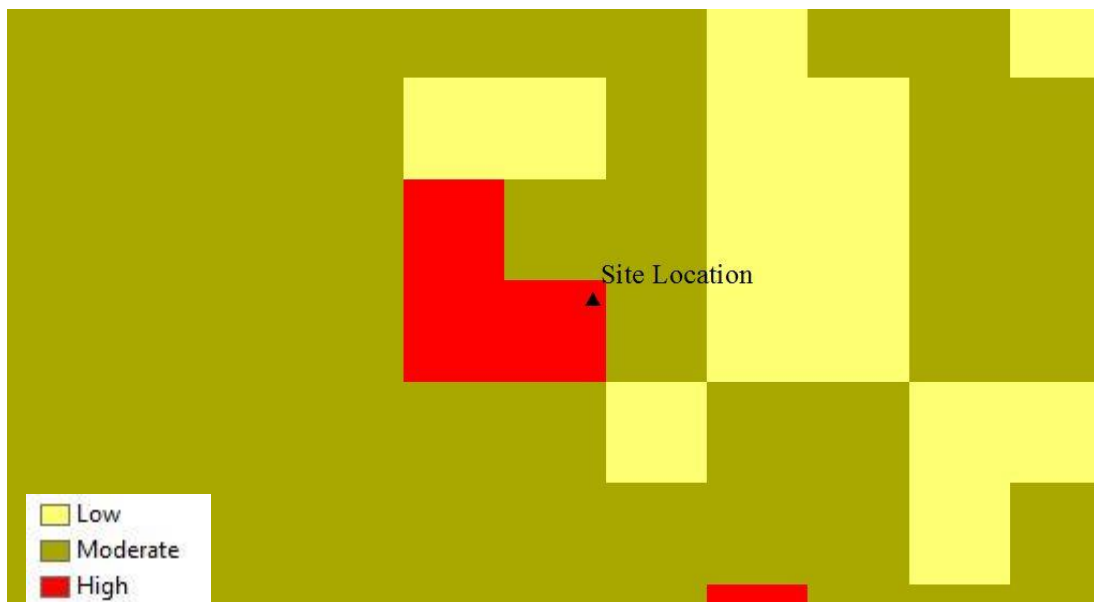
- Further, the study site falls under high susceptible zone as per the landslide susceptibility map of NLSM programme of GSI (Ankur Kumar Srivastava, Sr. Geologist and Neha

Kumari, Geologist, 2017: Marco Scale (1:50,000) Landslide Susceptibility Mapping in parts of Toposheet No. 48P/7, 11 & 12, Kodagu District, Karnataka). The adjacent areas also fall mostly under moderate susceptibility zone. This high to moderate susceptible zones should be either avoided for any future construction or utmost care should be taken if any future constructions are supposed to be carried out in these zones.

Figure – 1: Location of the site over landslide susceptibility map of NLSM programme of GSI
