**Landslide incidence of 02<sup>nd</sup> September 2017 on NH-5 near Dhalli area, Shimla district, Himachal Pradesh**

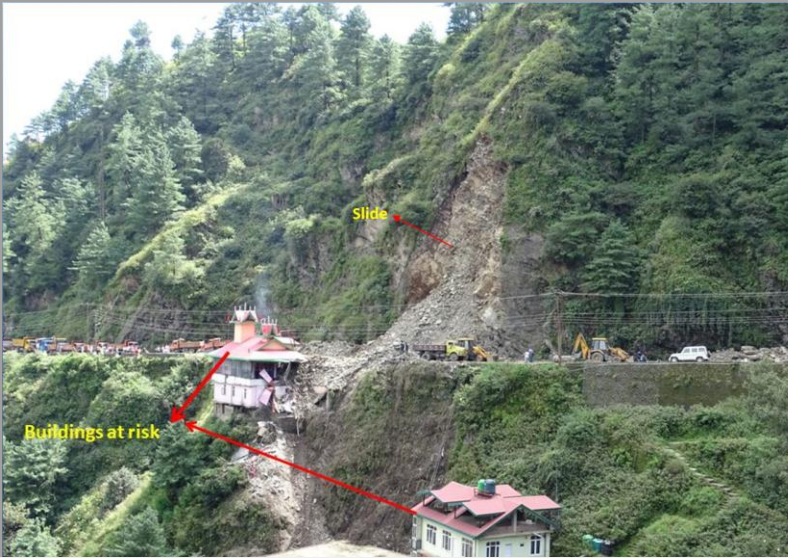
39	Photos. Sketch of Plan & section of the slide

33	Communication	Road damaged and blocked.
34	Infrastructure	A temple building partially destroyed.
35	Agriculture/forest/Barren	Nil.
36	Geo-scientific Causes	The cause of the rock slide is due to the presence of closely jointed weathered & distressed shale exposed on steep spur and road cut was made and left without any toe support. The presence of high relief, dripping scarp slope, proximity to nala have added to the vulnerability of the slope. The open joints form a wedge (J2 & J3).
37	Remedial measures	Scaling of loose rock mass on the slope, deep anchorage of rock mass with wire mesh shotcrete and adequate toe support.
38	Remarks, if any	<p>The slide is active and the settlements situated in the downslope are at risk and the dwellers should stay away till the remedial measures are applied. Local inhabitants and the appropriate authorities should be cautioned (also cautioned at the site). The geological consultation is necessary before any slope cut and for any further development of settlements.</p> <p>The area has already been classified under high landslide susceptibility zone, including the slide (Unpub. GSI report FS 2005-06).</p>

40	Summary/Abstract	Heavy monsoon rainfall triggered a massive rock slide (reactivated) on NH-5 near Dhalli area, Shimla district, Himachal Pradesh on 2 <sup>nd</sup> September, 2017 which resulted complete damage of few parked vehicles, blockage and damage of National Highway and partial damage of a temple building. No casualties were reported due to the slide.
41	Pdf
