A NOTE ON THE POST-DISASTER, PRELIMINARY ASSESSMENT OF THE REPORTED LANDSLIDE AT LAPTAP, PAPUM PARE DISTRICT, ARUNACHAL PRADESH

K. Sekhose, D. Pieru (Geologists) & Enos Ezung (Sr. Geologist)
State Unit: Arunachal Pradesh, Geological Survey of India, NER, Itanagar.

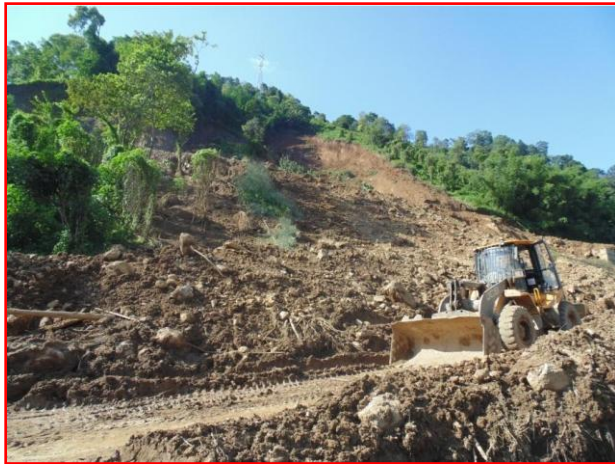
Fig-1: Laptap Landslide, PapumPare District, Arunachal Pradesh

28	Hydrological condition	Wet (saturated debris-soil due 4 days incessant rain prior to the landslide initiation).
29	Triggering condition	4 days antecedent rainfall.
30	Other factors	The slope has been recently excavated for road widening. A steep excavated slope was maintained.
31	Death of persons	14 persons
32	People affected	5 houses buried in slide and the villages connecting further Cut-off.
33	Live stock loss	Yes
34	Communication	Trans Arunachal Highway and village road are blocked.
35	Infrastructure	Yes
36	Agriculture/Forest/Barren	Orange orchard
37	Geoscientific causes	The saturation of the unconsolidated colluvial cover due to antecedent heavy rains led to drastic reduction in the shear parameters of overburden material. The cutting of road across the slope consisting of loose unconsolidated material also aided to the slope instability.
38	Remedial measures	<ol style="list-style-type: none"> 1. Slope easing through the removal of loose debris material. 2. A series of berms/benches may be put in place along the cut-slope with adequate protection on the backslope of each bench. 3. Suitable and effective drainage system (lined contour drains along the benches to prevent surcharge of the unconsolidated slope forming material). 4. Suitable breast walls and retaining walls may be provided with provision of weep holes in them.

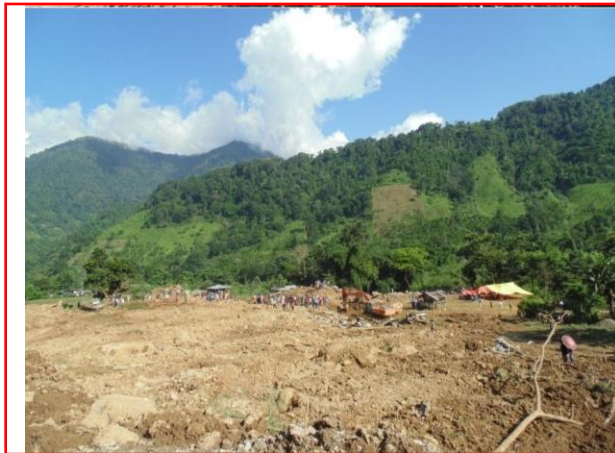
Fig-2: Downslope view of the Laptap Landslide showing the run-out path.

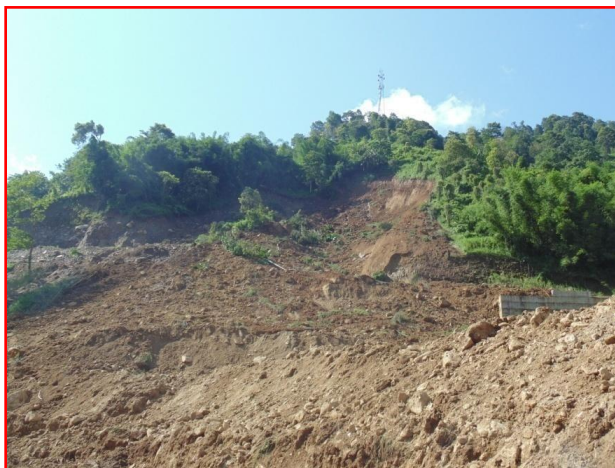
Fig-3: Upslope view of the Laptap Landslide along the Trans Arunachal Highway.

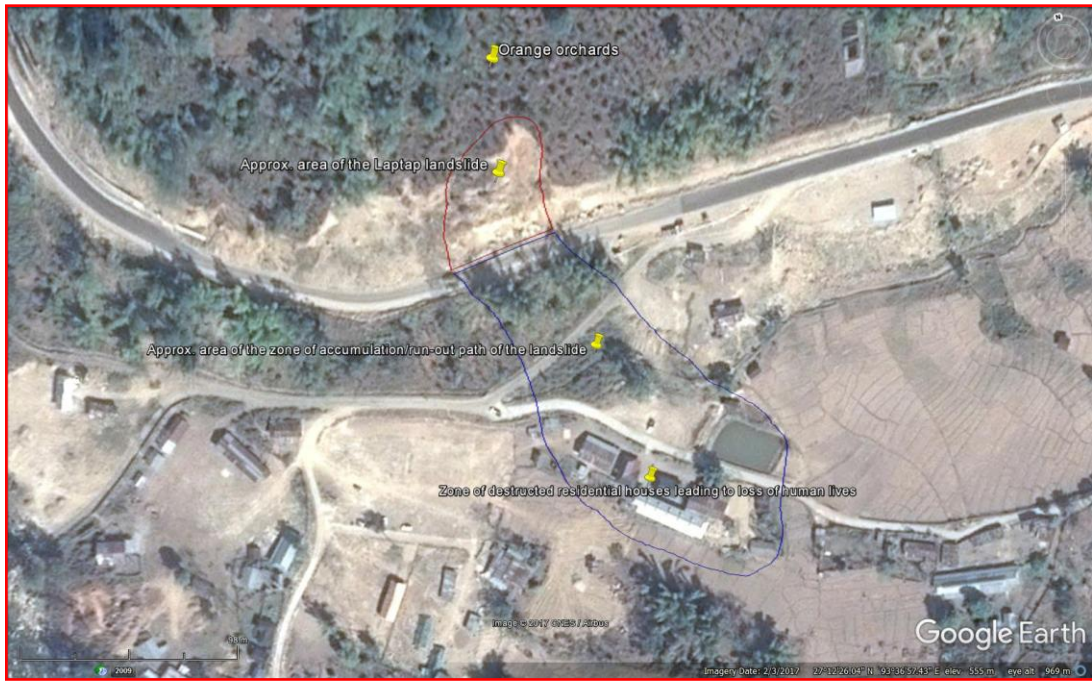
Fig-4: Google Earth image of the Laptap Landslide (March 2017).
