Landslide Incidences on NH-22, Solan district, Himachal Pradesh

By: Parveen Kumar & Dr. Vinod Kumar, Senior Geologists, GSI, SU: PHP, Chandigarh

| DATA SHEET FOR PRILIMINARY INVESTIGATION OF LANDSLIDE | | |

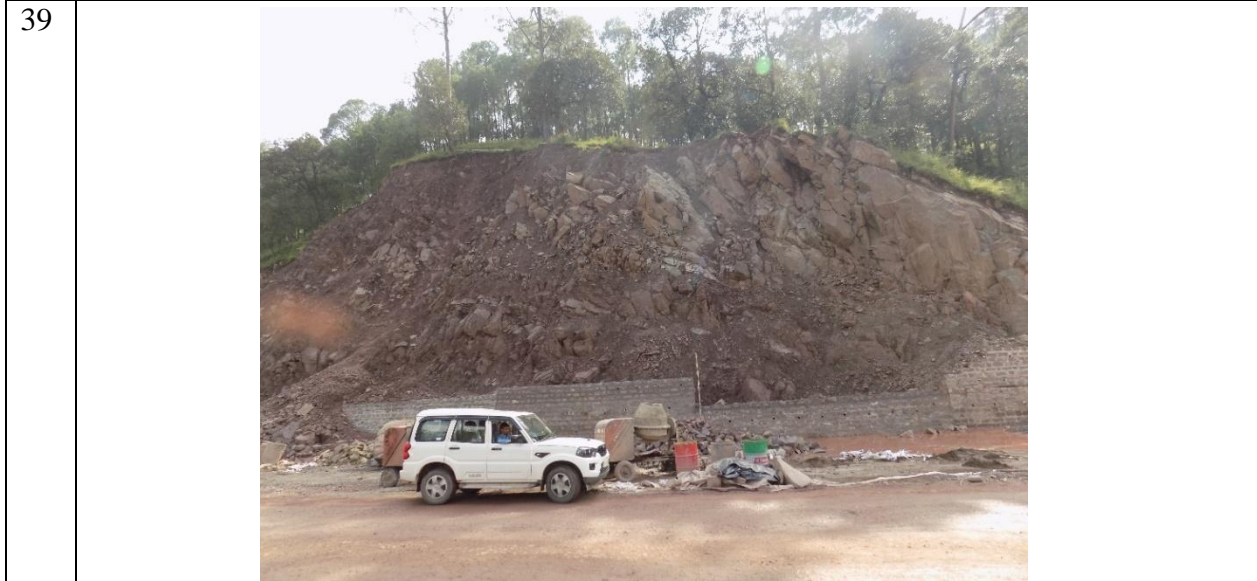
| DATA SHEET FOR PRILIMINARY INVESTIGATION OF LANDSLIDE | | |
|--|---|--|
| 22 | Failure mechanism | : <i>Shallow translational</i> |
| 29 | Triggering Factor | : <i>Rainfall/ road cutting, Highly Jointed rockmass</i> |

| 36 | Geo-scientific Causes | : | <i>Anthropogenic activities; unplanned cutting of slope, rainfall.</i> |

Field Photograph of Slide along NH-22, Chandigarh, Shimla, Road, at RD: 87+480

| 40 | Summary/Abstract | : | <i>Slide is a shallow translational slide and is active state Rock mass is jointed. Three main discontinuities are J_1(Bedding Plane):$30^0/N250^0$, J_2:$40-50^0/N135^0$, J_3: $45-50^0/N135^0$.Lithologically the slide comprises thickly bedded, alternate mudstone and sandstone bands of</i> |

| 37 | Remedial measures | : | -- |

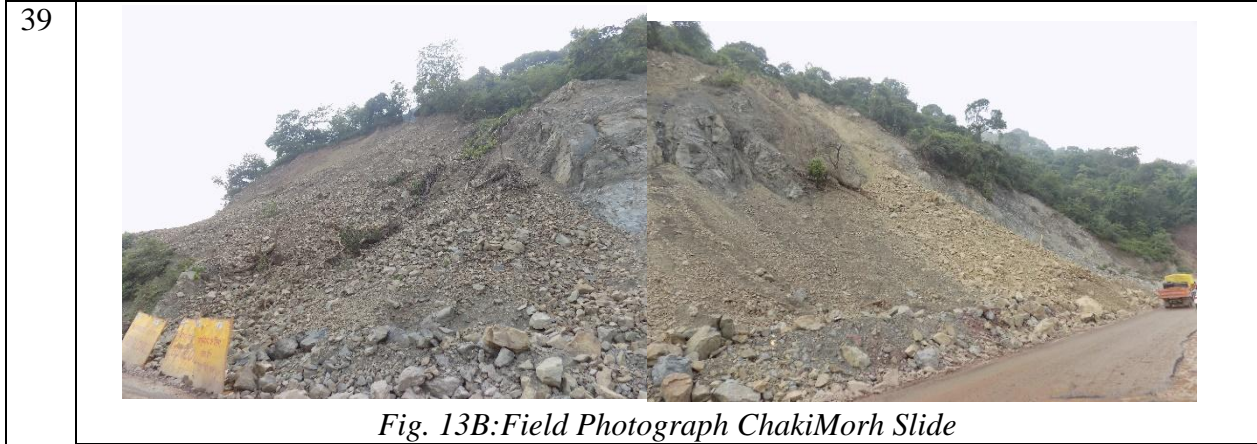
| DATA SHEET FOR PRILIMINARY INVESTIGATION OF LANDSLIDE | | | |
|--|---|---|---|
| 22 | Failure mechanism | : | <i>Shallow rotational</i> |

| 34 | Infrastructure | : | <i>Road, breast wall and retaining wall are damaged</i> |
| 36 | Geo-scientific Causes | : | <i>Anthropogenic activities; unplanned cutting of slope, rainfall, reduction of strength on saturation.</i> |

| 40 | Summary/Abstract | : | <i>ChakiMorh slide is a shallow rotational slide and is reactivated on 13-08-2018. Road blocked on the morning of 13/08/2018 at 6 am and opened up/cleared on the evening of 14/08/2018 at 3PM. Three Discontinuities recorded in the slide area J_1; (Bedding Plane) 30^0-40^0</i> |

| 38 | Remarks | : | <i>Detailed studies are required to provide suitable remedial measures for stabilization of slope.</i> |

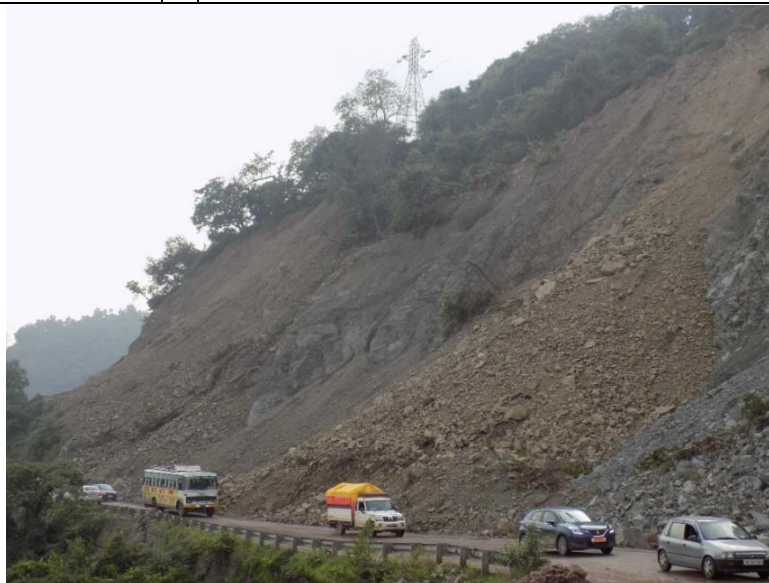
| 34 | Infrastructure | : | <i>Road, breast wall and retaining wall are damaged</i> |
| 36 | Geo-scientific Causes | : | <i>Unplanned cutting of slope, reduction of strength on saturation.</i> |

Field Photograph of Dattyar Village Slide at RD of 71+100 to 71+200 along NH-22

Dattyar Village Slide at RD of 71+100 is a rock-cum-debris Shallow rotational slide that got activated in the month of June 2018 during road cutting and reactivated on

| | | <i>13/08/2018 after heavy downpour. Lithologically, the slide area comprises alternate mudstone sandstone bands of Dagshai, Formation of Sirmour Group of Rocks. Main discontinuities recorded in the slide area are J₁ (Bedding Plane):65°/N270°, J₂ (V.D.):70-75°/N160°, J₃:45°/N225°, J₄:45°/N90°. The rockmass is sheared, shattered and crumbled. A shear zone on the right fringe is also present. Road, breast wall and retaining wall are damaged. The slide has resulted due to unplanned cutting of slope, making slope unstable and after heavy downpour the strength of the rock mass reduced due to saturation.</i> |

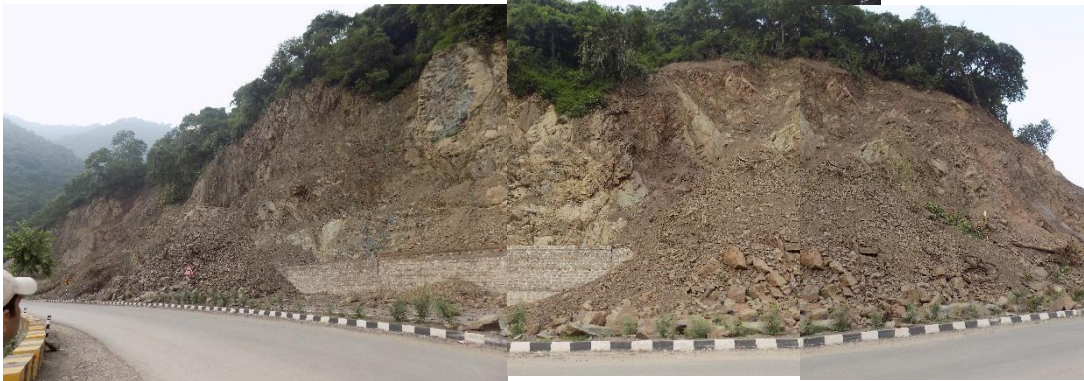
| 34 | Infrastructure | : | <i>Breast wall damaged</i> |
| 36 | Geo-scientific Causes | : | <i>Wedge failure, Reduction of strength on saturation, unplanned cutting of slope</i> |
| 39 | <p><i>Field Photograph of Dattyar Village Slide at RD of 70+750 to 70+950 along NH-22</i></p> <p><i>Location map of the slide NH-22/ RD: 87+480 (Source: Google Earth).</i></p> | | |
| 40 | Summary/Abstract | <i>Dattyar Village Slide at RD of 70+750 to 70+950 along NH-22 is a rock-cum-debris Shallow rotational and shallow</i> | |

| | | <p><i>planar slide that got activated in the month of June 2018 during road cutting and reactivated one week before the date of observation. Lithologically slide area comprise sandstone bands of Kasuali Formation of Sirmour Group of Rocks. Three sets of joints recorded in the slide area are J₁ (V.D.):40°-60°/N170°, J₂: 45°-75°/N260°, J₃:50°/N50°. Breast wall is damaged. The slide has resulted due to unplanned cutting of slope, making slope unstable and after heavy downpour the strength of the rock mass reduced due to super saturation.</i></p> |
