A NOTE ON LANDSLIDE INCIDENCE ALONG OLD IMPHAL-UKHRUL ROAD (NEW HEAVEN - LAMLANG GATE SECTION), UKHRUL DISTRICT, MANIPUR

Shri M. Pradipkanta Singh, Senior Geologist
 Shri N. Herojit Singh, Geologist
 and
 Dr. C. Debojit Singh, Director
 Geological Survey of India
 SU: Manipur-Nagaland, GSI Office, Imphal

Data sheet for preliminary investigation of landslide along New Heaven – Lamlang Gate section of Old Imphal – Ukhrul road, Ukhrul District, Manipur

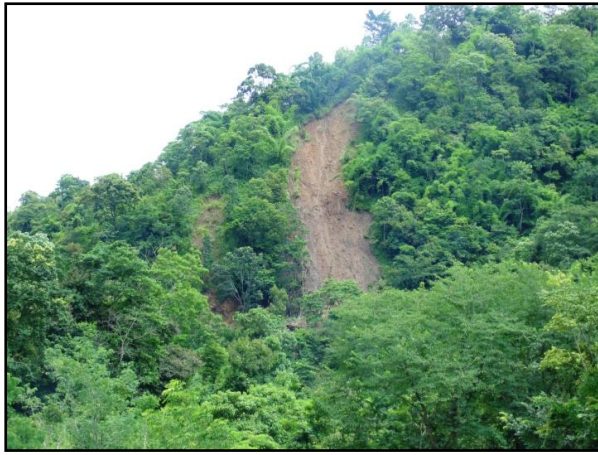
Fig. 4: A view of the landslide along New Heaven - Lamlang Gate section of Old Imphal - Ukhrul road.

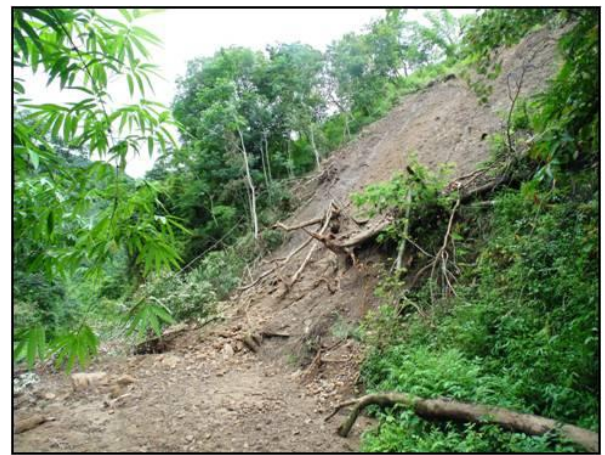
Fig. 5: Photograph showing sectional view of the landslide.

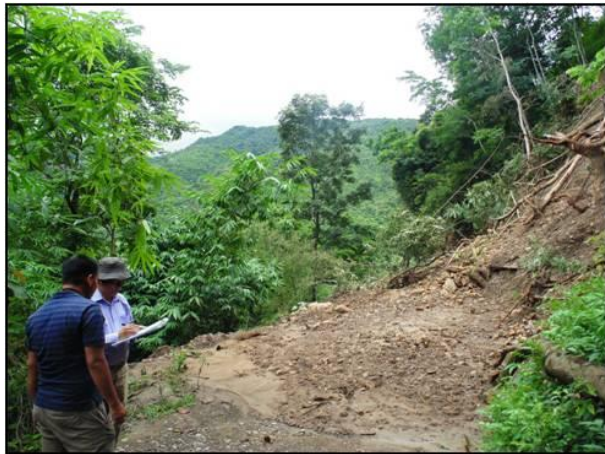
Fig. 6: Photograph showing total road blockage of New Heaven - Lamlang Gate section of Old Imphal - Ukhrul road.

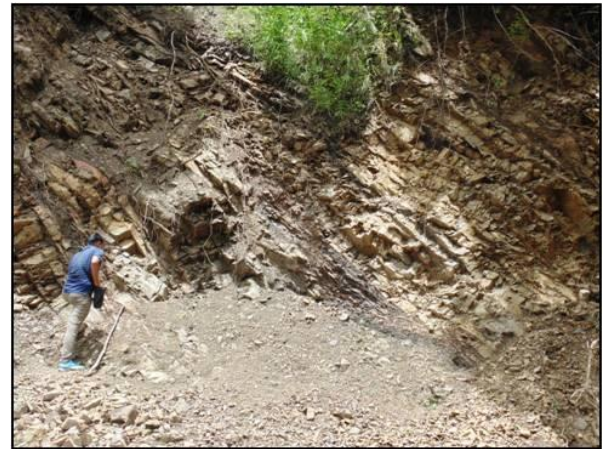
Fig. 7: Photograph showing highly jointed and weathered shale - siltstone - sandstone intercalation at the site of the landslide.
