**NOTE ON POST-DISASTER PRELIMINARY GEOLOGICAL STUDY OF THE
LANDSLIDE AT NH-102A, NEAR LEITING VILLAGE, UKHRUL DISTRICT,
MANIPUR**

Abhinab Borah, Geologist & Monotosh Mudi, Asstt. Geologist

Project Landslide, GSI-NER, Dimapur.

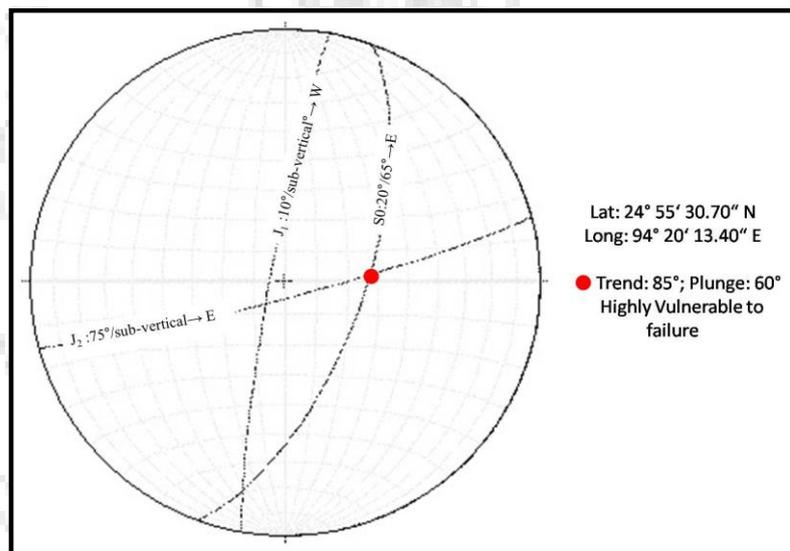
Heavy and frequent rainfall coupled with the lack of proper drainage systems has resulted in development of pore pressure within the lithic arenite material of Disang Formation. An important feature delineated within the slide is the network of rill erosion running parallel-sub parallel to the failure plane of the landslide (Photo 1, Photo 2). Secondary concave failure planes are traced for an approx. 5-8 m in length. The depth of the failure plane is more (>5m) which involves a large volume of slided material and it is a deep translational failure. A few prominent minor local scarps of variable length occurring within the body of the landslide have also been delineated. These minor scarps are indicative of secondary or later stage movements that have occurred subsequent to or in isolation to the large scale failure of the landslide which may be described as secondary or subsidiary scarps. The slide material is of soil type in nature and it is loosely compacted or bounded due to presence of less clay percentage.

The visual estimation of the slide along the scarp has indicated 70m length x 55m width x 60m height. Based on the disposition of the slide debris as well as the visually estimated overburden thickness, a planer slide along secondary developed interface has been interpreted towards the up side of the landslide body. The primary triggering factor of the landslide is the rainfall. A combination of factors like steep slopes (average 47°), presence of weak rockmass comprising weathered splintery shale, percolation of water during incessant heavy rainfall leading to saturation of the poor slope forming material and a resultant reduction in the cohesive strength

1. Since the road segment appears to be constructed over the filled dumped material hence it would be advisable to provide gabion wall on the hill side of the road.
2. Proper lined contour drains are recommended to channelize the surface runoff away from the slide zone and to prevent the percolation of water in substratum.
3. Immediate removal of debris material.
4. Warning sign board may be installed on either side of the slide zone to caution the commuters.
